# Operation and Maintenance of Secondary Reformer – Lessons from Plant experiences

Sk Shafi Ahmed<sup>a\*</sup> and Md. Enamul Haque<sup>b</sup>

<sup>a</sup>Chief Operations Officer, Karnaphuli Fertilizer Company limited; Rangadia, Anowara, Chittagong

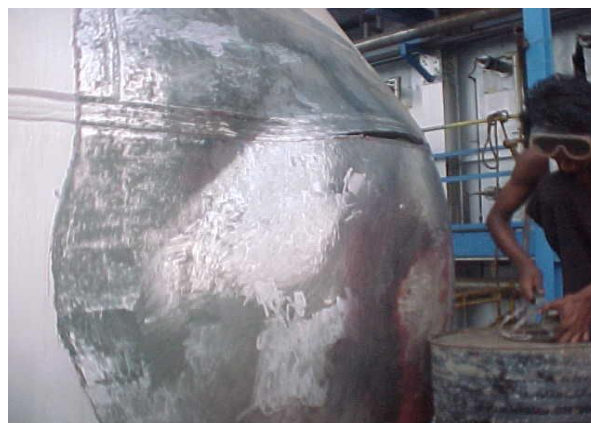
Failure Time: 06:45 hr in the morning  
Bulging Area: 1400mm x 600mm  
Bulged height: 250 mm (max)  
Bulged area bears a clear hot spot mark  
Crack developed: Horizontal crack in the bulged area of the welding point  
Crack dimension 700 mm x 50 mm

The refractory on top conical part in the bulged area has been shifted outward (toward burner); appeared a number of long cracks in and around  
Damaged area ranging in width from 10-20 mm.

Figure 1: Bulging of 2RF Shell

The shell was over heated above 350C.; and a bulging effect due to huge gas pressure on the conical portion happened. The process gas of 1300 C has touched the inner metallic surface of the shell in the conical portion. Very big and long cracks have developed within the castables during plant operation and the castables have fallen in some areas due to cutting of the anchors. The anchors bond the castables with the metal surface. The big crack developed within the castables has allowed process gas to reach the metal shell and overheated the Carbon steel metals.

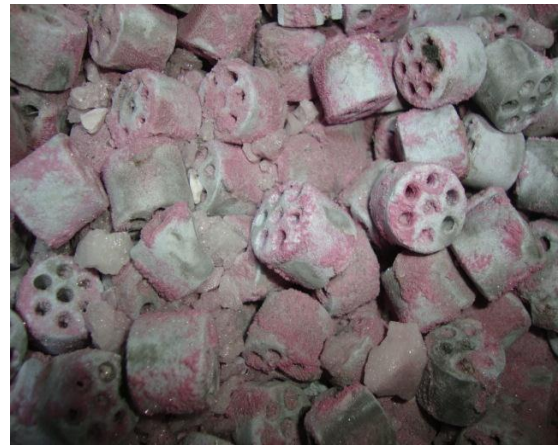
Figure 11: Catalyst with Dust and ruby colour

Under the top layer catalyst bed - lots of catalyst dust was and ruby formed catalyst presence.

Catalyst is carefully monitored during all or alternate Turnarounds (TA). All broken catalyst; dust and agglomerated catalyst is removed during this period. The whole bed in unloaded to do the job. The catalyst unloading help inspection of the bottom arch.

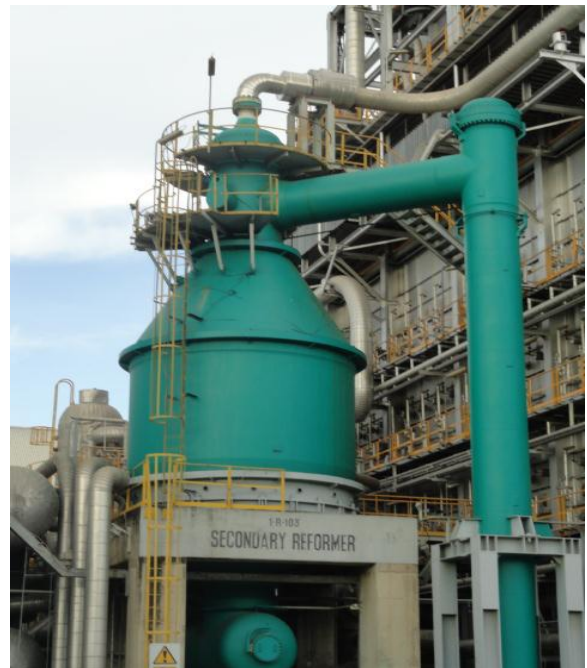
Figure 12 Metallic Shell of 2RF with temperature sensitive paint
