STEAM BOILERS IN READY-MADE GARMENTS INDUSTRY IN BANGLADESH: EXISTING SCENARIO AND SCOPE FOR DEVELOPMENT

¹Boiler Safety Engineering Department, RMG Sustainability Council, Dhaka, Bangladesh

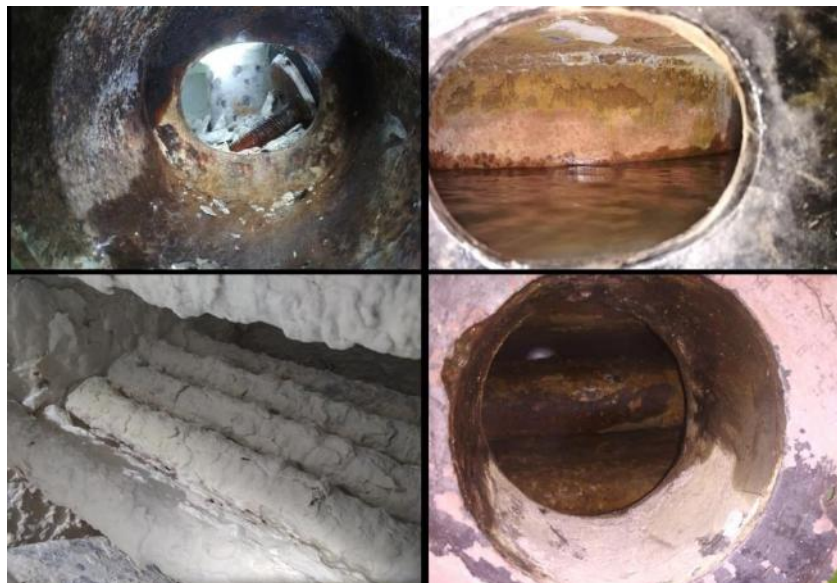
Figure 1: Corrosion of the metal and scale formation inside the boiler for using untreated water (Accord, 2019; Siraj *et al.*, 2023)

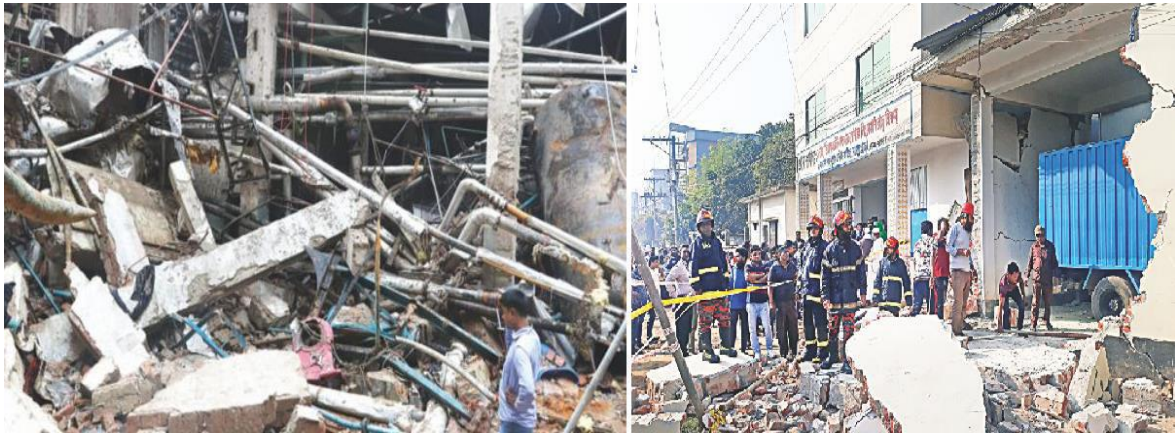
Figure 2: Boiler explosion at Multifabs Ltd on July 3, 2017 (Left) (“Boiler explosion”, 2017), and at Natural Sweater Village Ltd on December 10, 2019 (Right) (“One killed”, 2019)

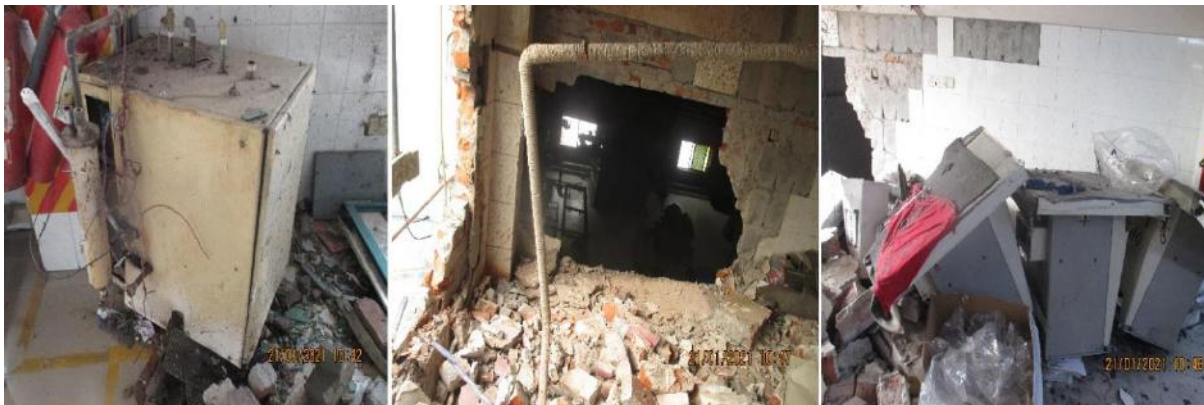
A common stereotype was established among the factory owners that, only large boilers could explode, and mini-boilers were safe. Even the Boiler Law-2022 by the government of Bangladesh supported this stereotype by declaring that steam generators whose water storage capacity is less than 25 liters are not boilers (Laws of Bangladesh, 2022). Therefore, the office of the CIOB does not have any legal obligations to inspect such boilers. However, the explosion of such mini-boilers can also be devastating. For instance, an explosion of a mini-boiler took place in Sincere Composite Ltd at Narayanganj on January 19, 2021, and which incident was investigated by the RSC on January 21, 2021. Figure 3 is depicting the post-explosion severity at the factory.

Figure 3: Mini-boiler (left), collapsed boiler room (middle), impact on the adjacent production floor (right); observed during the Incident inspection by the RSC at Sincere Composite Ltd.

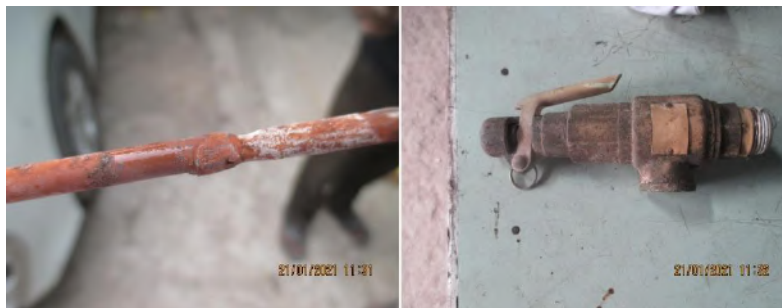
The inspectors of the RSC found a non-compliance operational issue behind that explosion. They reported, the factory modified the level sensor of the boiler by increasing its length, which caused a dry-run of the boiler.

Moreover, the mechanical safety valve got stuck due to irregular maintenance and rust formation. Figure 4 is showing the investigated causes of the mini-boiler explosion at Sincere Composite Ltd.

Figure 4: Lengthening the level sensor by welding (left), rusted stuck safety valve (right); observed during the Incident inspection by the RSC at Sincere Composite Ltd.

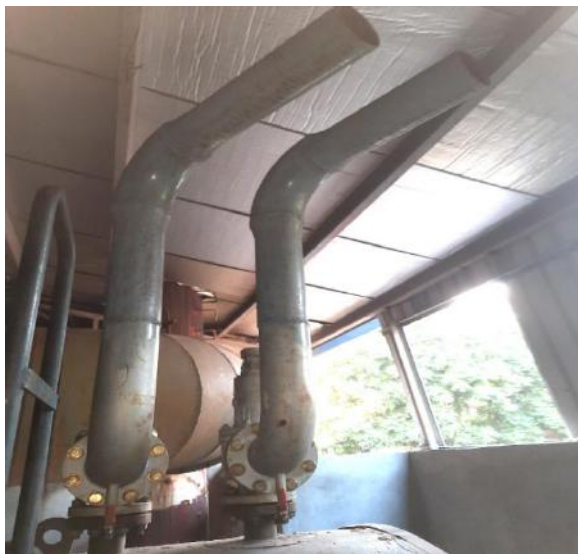
Figure 8: Safety valve discharge point inside the room

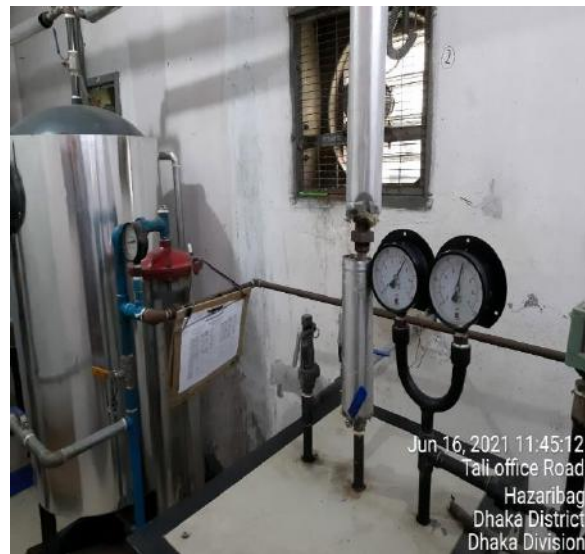
Figure 9: Different steam pressure at two gauges

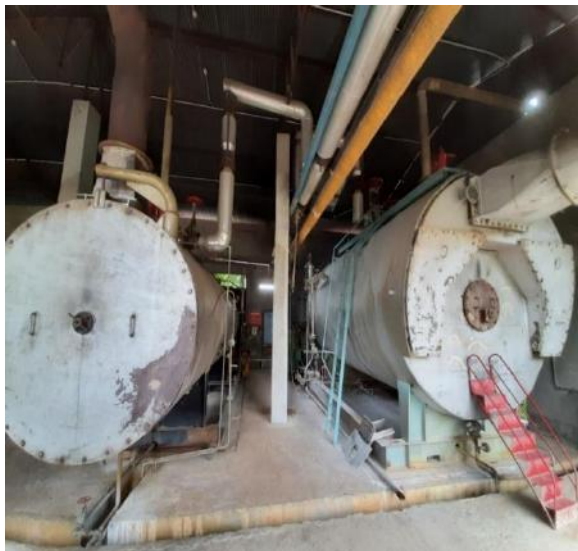
Figure 10: No railing for the service platform of boilers

Risk categories	Risk factors	Remediation suggestions
Platform	The boiler handrail, platform, and ladder are not provided/ are inadequately supported.	A Suitable and properly supported boiler handrail and platform shall be provided with proper ladder access.

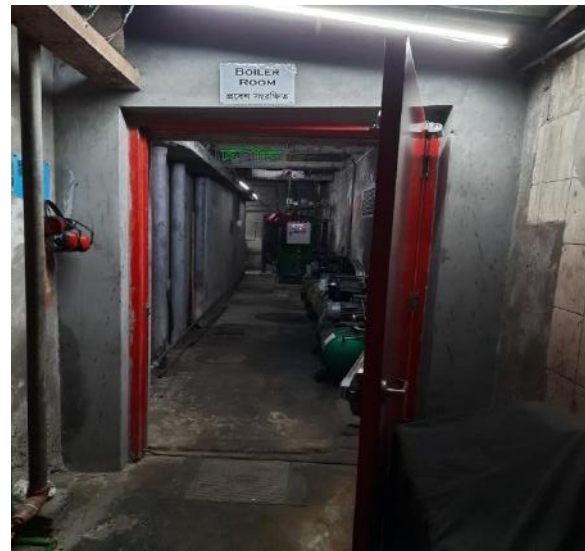
Figure 11: Inadequate clearance, obstructed ventilation

The boiler room does not have adequate ventilation systems.	An adequate ventilation system shall be ensured as per BNBC for combustion air, habitability, housekeeping, personal safety, and general safety considerations.
	The equipment has insufficient maintenance and inspection clearance.	The front or rear of any boiler shall not be located nearer than 36 inches (915 mm) from any wall or structure. There shall be at least 36 inches (915 mm) of clearance on each side of the boiler and other equipment to enable access for activities.
Documentation	The boiler is found operational without government authorization.	The factory shall have a boiler registration certificate and shall not operate the boiler until the registration certificate is available on-site.
	The boiler registration renewal was expired/ not available.	The factory shall apply to the appropriate authority for a registration renewal certificate and ensure an updated renewal certificate is available on-site.

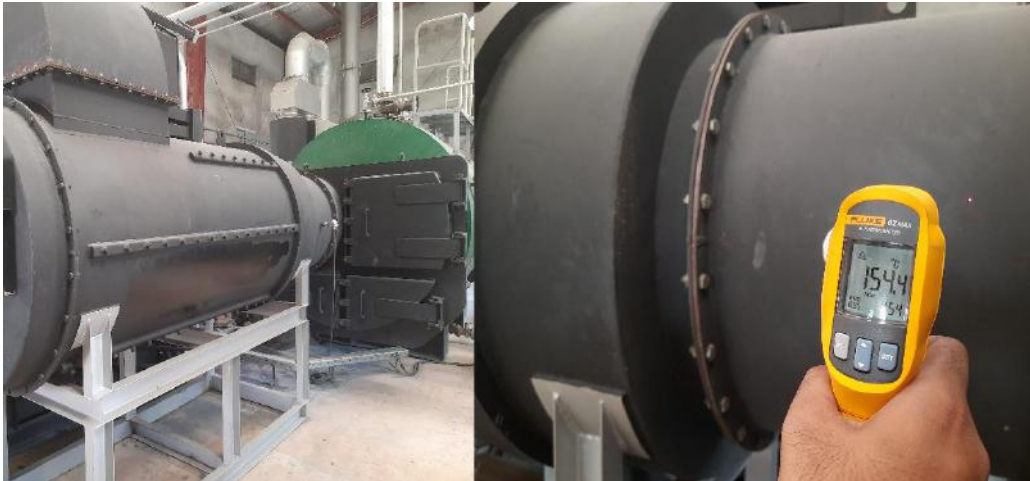
Figure 12: Uninsulated hot surface in the boiler room

Installed safety valves are inadequate according to the manufacturing standard.	Proper sized/ adequate number of safety valves on the boiler shall be ensured following the relevant standard.
	Control valve is observed between boiler and safety valve.	The safety valves shall be mounted directly on the boiler shell without any control valve in between them.
	The safety valve discharge pipe diameter is reduced from the inlet pipe diameter.	The diameter of the discharge pipe of the safety valve shall not be reduced from the diameter of the inlet pipe.
Hot Surface	Boiler body and steam pipes were found with improper insulation.	Proper insulation shall be provided to all equipment in the boiler room that is causing heat exposure of more than 60 degrees Celsius.
	The steam line connection is not terminated properly.	Any unprotected steam line shall be terminated in an appropriate manner that does not create any possibility of burn hazard.
