## Status of Radiation Protection Measures in Private Medical Facilities in Pirojpur District of Bangladesh

Radiation safety is a key concern to protect workers, patients, and the public from ionizing radiation. This study investigates the status of radiation protection in 35 private medical facilities in Pirojpur district through field inspections, structured interviews, and radiation dose measurements, in accordance with national safety standards (BAER Act-2012, NSRC Rules-1997, and Regulatory Guides). The results show that 60 % of facilities lack a certified RCO, and 34 % of facility operators do not use a personal monitoring device, violating Sections 54.0, 58.1, and 59.1 of the NSRC Rules-1997. While most of the X-ray rooms are undersized, 86 % meet wall thickness requirements (Regulatory Guide for Diagnostic X-ray). 80 % of facilities have radiation warning signs and 88.5 % of facilities use PPE, which are safety requirements according to Sections 55.2 (a), 18.2 (22), and 83.1 (b) of NSRC Rules-1997. Radiation doses at control panels were within the limit in most cases, but the doses at the entrance doors were not satisfactory. The use of shielding materials was sufficient i

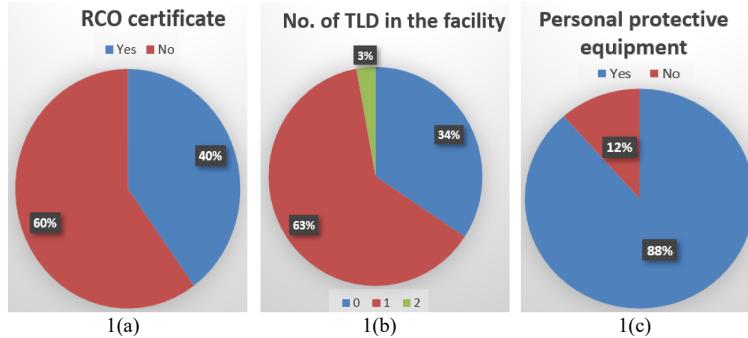
The status of radiation monitoring equipment and knowledge about radiation-related activities for personnel are shown in Fig. 1. Here, in Fig. 1a, we found that about 60% Radiation Control Officers (RCOs) of medical facilities in Pirojpur district do not have RCO certificates, which is a requirement according to Section 54 of NSRC rules-1997.

Thermoluminescent dosimeter (TLD) is a radiation measuring device used for personnel radiation monitoring, which is recommended for operators by Sections 58.1 and 59.1 of NSRC rules-1997. As shown in Fig. 1b, 63 % medical facilities in Pirojpur district have one TLD Badge, 03 % have two TLD Badges, and 34 % do not have any TLD Badge.

Personal protective equipment like Lead Apron, Lead Thyroid Collar, Eye Goggles is very important for operating personnel's safety from ionizing radiation, and the use of personal protective equipment is a mandatory safety requirement according to Section 18.2 (22) and 83.1 (b) of NSRC Rules-1997. From the Fig. 1c, it can be observed that about 88.5 % medical facility in the Pirojpur district has this type of protective equipment.

Fig. 1. Status of operating personnel's qualification, availability of radiation measuring device, and personal protective equipment of the radiation facilities in Pirojpur district. (a) Radiation Control Officer (RCO) certificate, (b) availability of thermoluminescent dosimeter (TLD), (c) availability of personal protective equipment.

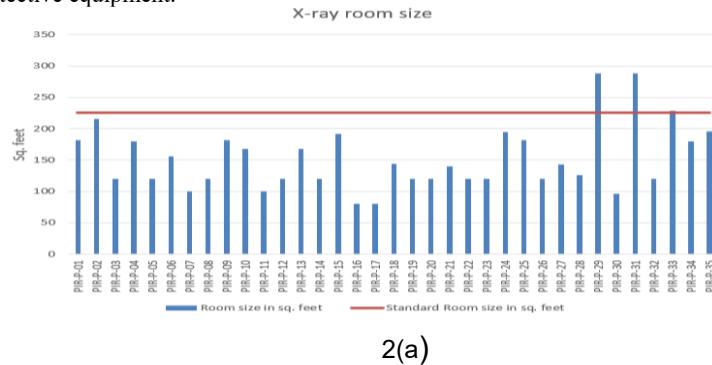
2(a)

The room where the radiation-generating equipment is installed should follow some direction to protect patients and attendants from radiation. Chapters 8 and 9 of the Regulatory Guide on Radiation Protection in Medical Diagnostic X-ray specify regulatory standards for room dimensions and wall shielding of X-ray rooms of medical facilities, where the minimum room size is 225 square feet and the minimum wall thickness of X-ray rooms is 10-inch brick wall [13]. In Fig. 2a, it is clear that most of the radiation facilities in the Pirojpur district have not met the standard room size requirements [13]. A significant

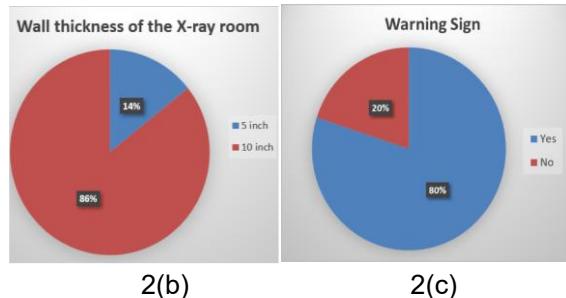
2(b) 2(c)

improvement is required in this area. About 86 % facilities in this district meet the wall thickness requirement, as shown in Fig. 2b. The presence of radiation warning signs outside the X-ray room is another regulatory requirement according to section 55.2 (a) of NSRC Rules-1997. From Fig. 2c, it has been observed that about 80 % radiation facilities in the Pirojpur district have radiation warning signs, which indicates a good practice.

Fig. 2. Assessment of room size, wall depth, and warning signal of the radiation-generating room of X-ray facility in Pirojpur district. (a) X-ray room size, (b) Wall thickness of X-ray room, (c) warning signs outside the room.

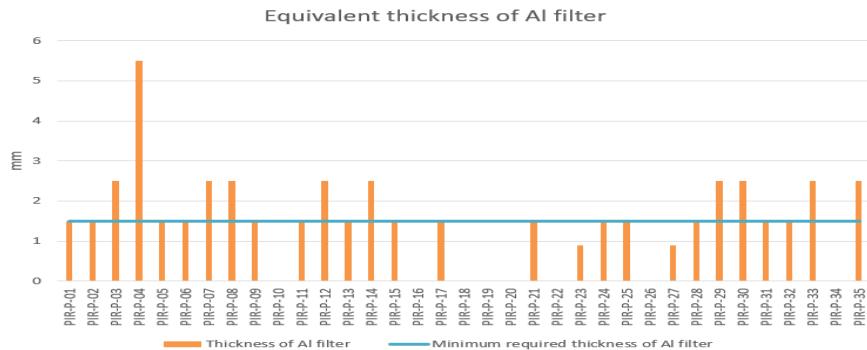
The thickness of the aluminium filter of the X-ray tube plays an important role in beam quality control and patient safety. The aluminium filter is used to perform filtration to remove low-energy X-rays from the beam before it exits the X-ray tube. Low-energy X-rays are absorbed by superficial tissues, thereby increasing patient dose without contributing to image formation [20]. The minimum required thickness for an aluminium filter for an X-ray tube is 1.5 mm according to the national standard. Fig. 3 shows that most of the facilities of the Pirojpur district fulfil this requirement.

Fig. 3. Thickness of aluminium filter in X-ray tube of X-ray facility in Pirojpur district.

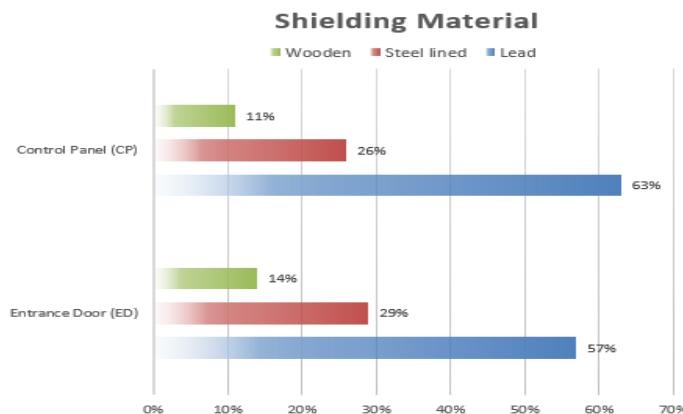
A clear assessment of shielding for radiation protection of radiation-generating equipment in the Pirojpur district has been presented in Fig. 4. Most of the facility in this district has good radiation protection structures [13]. The entrance door of 57 % facilities and the Control panel of 63 % facilities have led as shielding material. Some facilities use steel-lined shielding at the control panel and entrance door. A few facilities have a wooden structure, which does not fulfil the regulatory requirement.

Fig. 4. Radiation shielding assessment for radiation protection of the radiation facility in Pirojpur district.

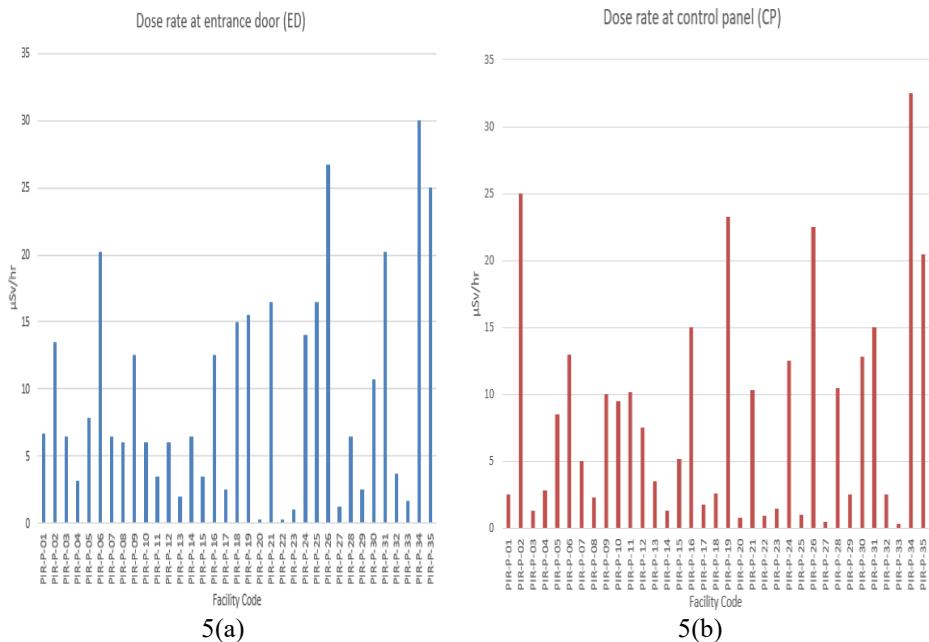
Radiation dose rate measurement in various locations of the X-ray room is the most important part to ensure the safety standard of that room against radiation. Dose rate of the entrance door, control panel, wall of the room, window, etc., is carefully evaluated. Since occupational workers operate the X-ray machine from near the control panel, the radiation dose at the control panel is considered occupational exposure. Similarly, the dose at the entrance door is considered as public exposure. In Fig. 5a, we found that the shielding condition at the entrance door in most of the facilities of Pirojpur district is not adequate to fulfill the requirements. The highest dose rate at the entrance door is recorded as 30  $\mu\text{Sv/h}$  (PIR-P-34), where the permissible dose limit for public exposure is 0.5  $\mu\text{Sv/h}$  according to the national standard [9,21,22]. From Fig. 5b, it has been observed that the control panel shielding in 71 % facilities is good and within the permissible limit for occupational exposure (10  $\mu\text{Sv/h}$ ) according to the national standard [9,21,22]. Although the dose rate in the control panel of some of the facilities is higher than the regulatory requirement.

Fig. 5. Measured radiation dose in various locations of the radiation facility in Pirojpur district. (a) dose rate at entrance door (ED), (b) dose rate at control panel (CP).
