## MICRO-CATCHMENT RAIN WATER HARVESTING TECHNOLOGY IN CONSERVATION AGRICULTURE AND PLANT PRODUCTION

MERYEM KUZUCU\* AND İBRAHİM SAMET GÖKÇEN

*Kilis 7 Aralık University, Faculty of Agriculture, Horticulture Department 79000, Kilis/Turkey*

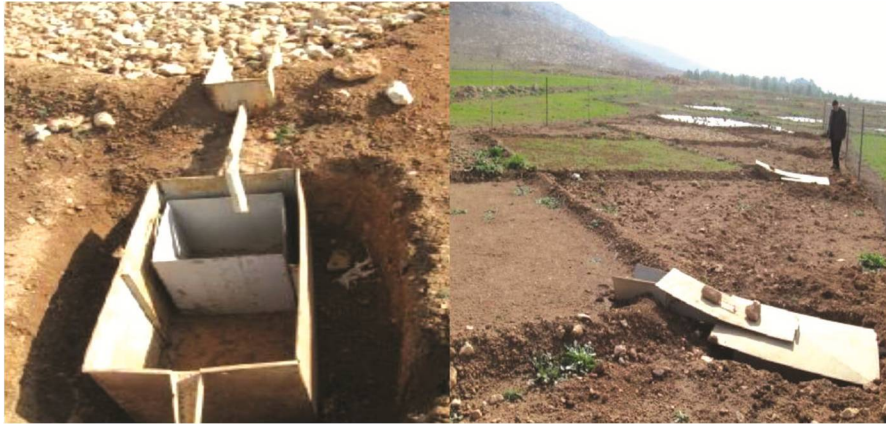
Fig.5. Stone Cover and Surface Compaction Runoff and Sediment Measurement System (Kuzucu 2013).

controlled manner. Rainwater harvesting is an economical and beneficial practice for these regions. Evaporation losses, runoff and accompanying erosion damage in arid areas can be controlled by appropriate rainwater harvesting technique (Oweis *et al.* 2001). In the semi-arid conditions of the Southeastern Anatolia region Şanlıurfa, the 30-year average temperature was 18°C, the precipitation was 344.1mm, and the evaporation was 2047mm. Micro-catchment rainwater collection systems are based on the collection of runoff at small distances in the root zone. Flow water is stored in the areas where it is collected or delivered directly to the plant root zone. These systems are useful application for trees, shrubs or annual plants (Oweis *et al.* 1999). The size of the basin can range from a few square meters to an area of 1 decare. These structures are constructed to direct the runoff towards the lowest point of the plant where the plants are placed. Negarim microcatchments are often beneficially used for fruit trees with high economic value such as pistachio, apricot, olive, pomegranate and almond (Oweis *et al.* 1994). In the present study, runoff and sediment were measured in 45 negarim microcatchments, 15 from each mulch cover. In the trial area, which has semi-arid climatic conditions in the Southeastern Anatolia region, an average of 299 mm of precipitation was received in three water years (2010-2011-2012). In the pistachio orchard with an average slope of 6%, microcatchment water harvesting, natural, clean water was provided for the plant with various mulch applications, sediment and surface flow losses were prevented by mulching and erosion control were also provided in this sloping orchard (Kuzucu 2013). Here the effectiveness of mulch covers for erosion control was compared. Runoff and sediment losses from rainfall were also measured after each rainfall. The rainwater runoff and sediment transported by rainwater between the experimental subjects were measured by collecting them in a collection container with a sheet metal gutter placed at the bottom of the micro-basins. After each rainfall that caused runoff, the lid on the runoff tank was opened and the water height was measured. The water in the tank was mixed and suspended and 2 liter sub-samples were taken and analyzed in the laboratory to calculate sediment losses. In this way, the cover material that realized the best surface runoff and reduced sediment losses among the cover materials used was determined (Fig. 5). Precipitation and temperature falling in the research area monitored by an automatic climate station and evaporation monitored daily from the evaporation tank was measured. Plant height was measured with a meter. Experimental design and experiment area map are presented in Figs 6 and 7.

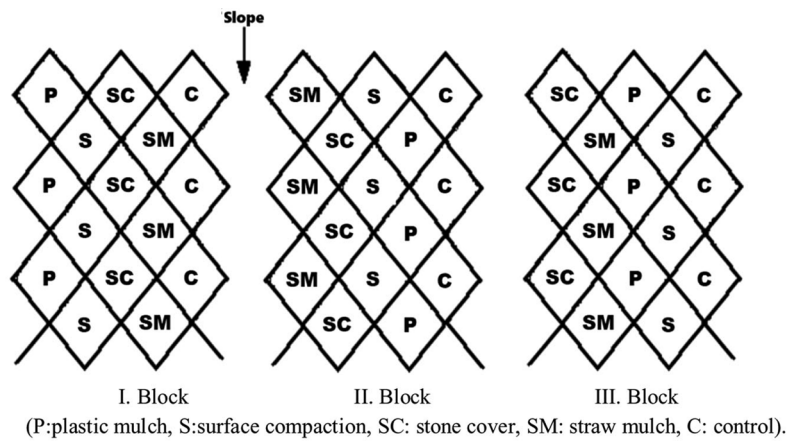
Fig. 6. Experimental Design.

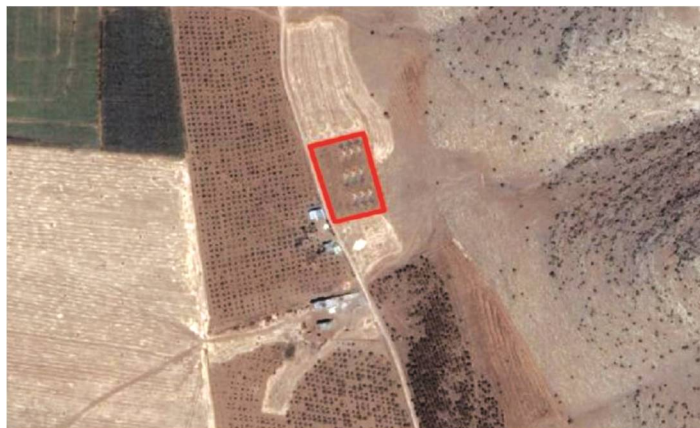
Fig.7. View of the Experimental Area.
