## **Introduction to Fiber Reinforced Composite (FRC) Post, A New Era in Reinforcing Esthetics: A Case Report**

### **Abstract**

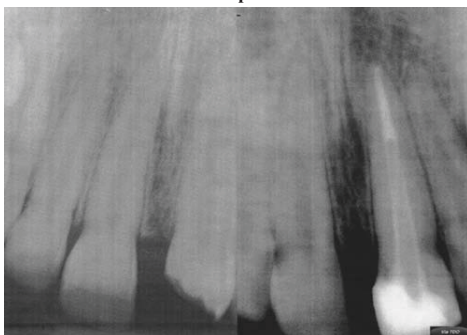
Fig 3: Radiographic view of a glass fiber post in the maxillary left central incisor.

Other types of fiber posts also are available, including quartz fiber, glass fiber, and silicon fiber posts (Figs. 1 and 2). They are claimed to offer the same advantages as the carbon fiber posts, but with better esthetics. Because they are newer, there is currently less research available on them than carbon fiber posts. Most fiber posts are relatively radiolucent and have different radiographic appearance than traditional posts (Figs. 2 and 3).

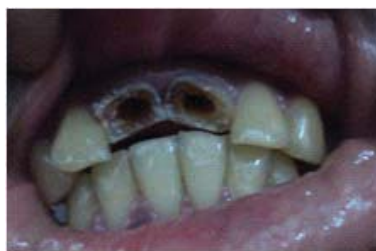
1) Diagnostic Photo

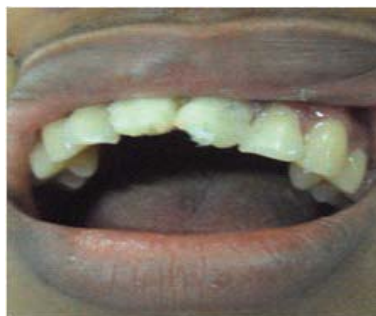
2) Photo taken after Post-core preparation

The post was carefully seated into the canal using light finger pressure it was light cured for 40 seconds for proper depth cure with Halogen light. Excess cement expressed out of the canal was used as a base for core buildup (as Fig:8 suggests). Light cure packable composite resin was used as a core material. After packing & giving a desired shape it was cured for 30 seconds with Halogen light. After setting, minimal preparation was carried out to finish the margins for crown preparation so that, the margins of the crown extends over the core material and lie on a sound tooth structure. In this way, the crown forms a collar, which surrounds the cervical parts of the root which is called a 'Ferrule'<sup>11</sup>. A ferrule of 1.5 mm was given above the crown margin area, which embraces the circumference of the root, thus protecting it from fracture & ensures the longevity of the artificially prepared & seated crown<sup>12,13,14</sup>. Then an impression was taken & shade was selected to fabricate the all ceramic crown.

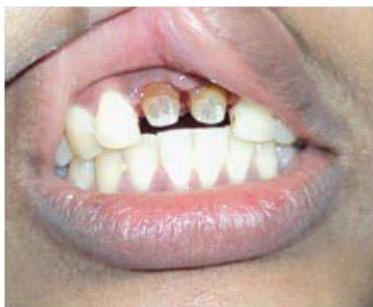
3) Photo taken after tooth preparation for crown

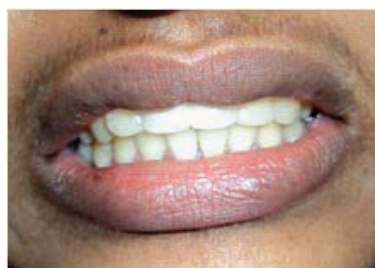
4) Photo taken after crown insertion
