Accidentally Broken Lateral Incisor Tooth at the Gingival Margin Treated by Endodontics, Cast Post and Core Finally Porcelain Jacket Crown: A Case Report

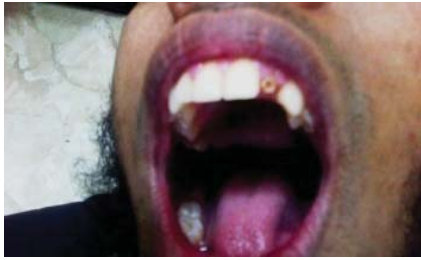
Figure 01: Accidentally broken left lateral incisor.

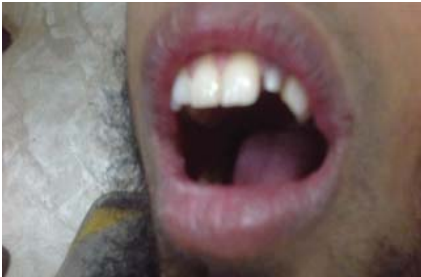
Figure 02: Tooth preparation and cast core fitted.

Under L.A. (Local Anesthetics) the pulp tissue was removed and the canal was irrigated with normal saline. A working length radiograph was taken and working length was estimated. Finally the obturation of the root canal has been done properly. During the next visit, both hand instrument and rotary safe ended post space preparation drills were used to remove condensed gutta-percha until the desired post space depth was achieved leaving the apical 4mm to maintain the hermetic seal. Copious irrigation was done not only to remove the obturation material but also to avoid any damage because of the heat production. The remaining coronal part was prepared by incorporating a ferrule design to encircle the external dimension of the residual tooth. A cast post was fabricated indirectly on a cast, which was obtained from an impression using silicon impression material. Finally the cast post and core were subsequently cemented and the preparation was completed for a full down coverage.

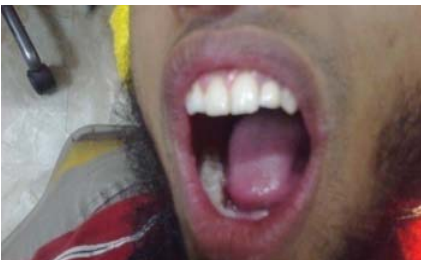
Figure 03: Finally tooth covered with acrylic jacket crown.
