Case Report

Management of a Failed Hybrid Implant Full-arch Prosthesis- A Case Report

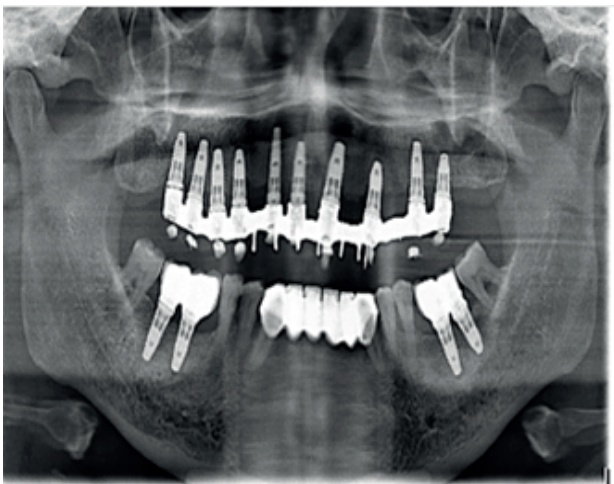
Figure:1 Preoperative Hybrid Maxillary prosthesis

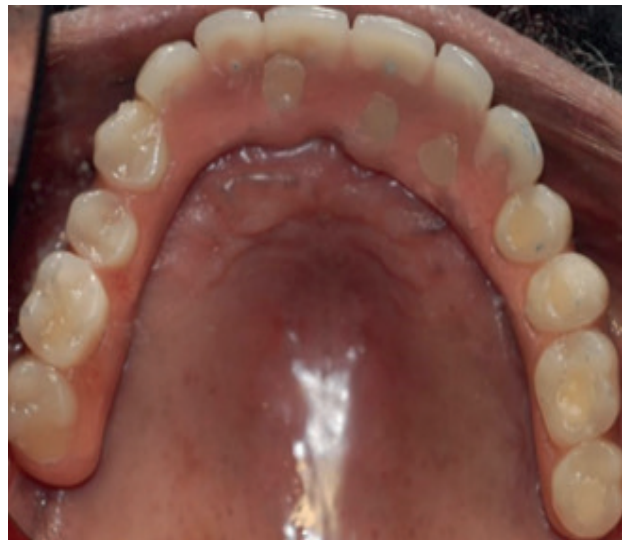
Figure 2: Postoperative Hybrid maxillary prosthesis

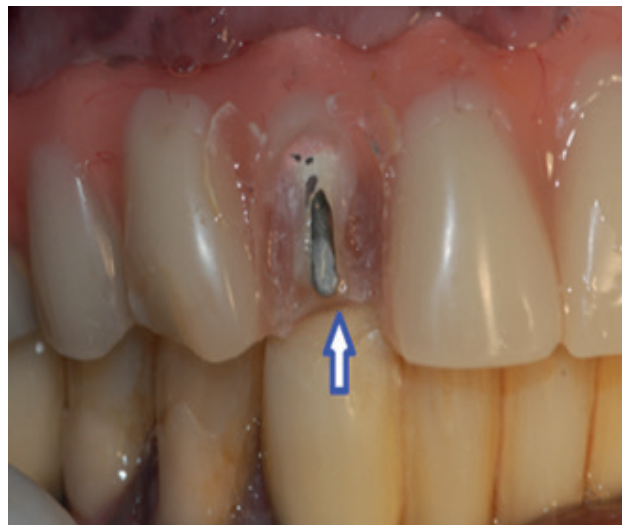
Figure 3: Fractured lateral incisor on the prosthesis.

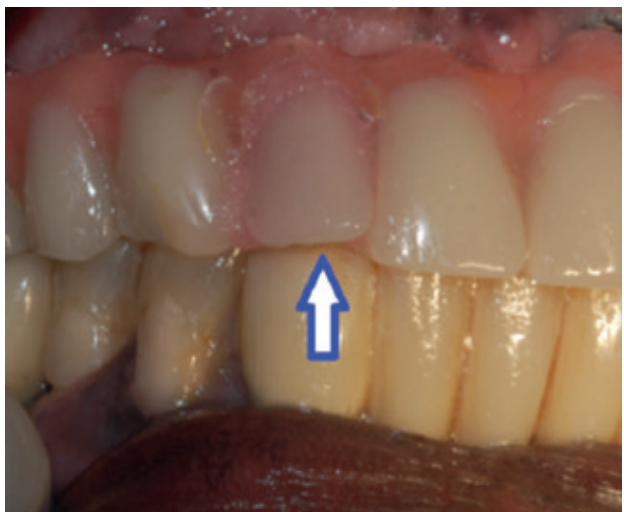
Figure 4: Repaired lateral incisor.

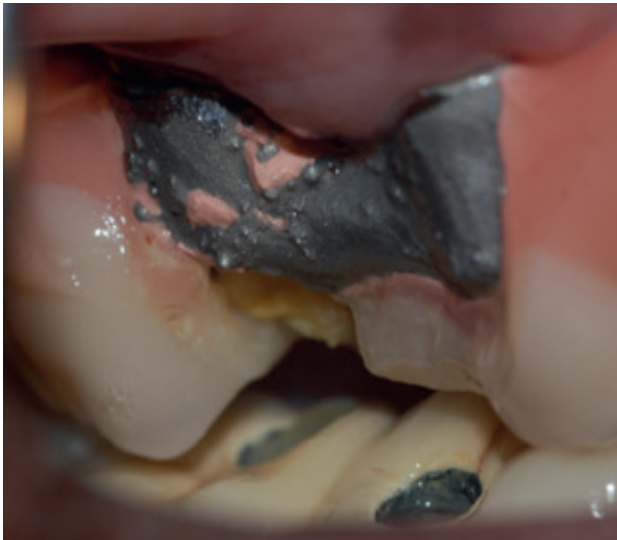
A 55-year-old, male retired bank manager, was referred by a general dentist with the complaint of frequent fractures of acrylic from the maxillary hybrid implant bridge that was delivered 6 months ago. A fixed ceramic implant bridge was already present at the lower left first molar (36), lower left second molar (37), Lower right first molar (45), and lower right second molar (47). He has already had a fixed bridge in the lower anterior for the past 5 years and is happy with it. The referring dentist provided the post-surgical radiograph **Figure 1** and the post-prosthetic image on the day of delivery **Figure 2**. The patient's chief complaint was the continuing repairs that had to be done in the denture on different teeth and the gingival area of the prosthesis within the few months of prosthesis insertion. The patient requested a repair again and wanted a permanent solution to the fracture of the prosthesis issue. On clinical examination, the fracture of the anterior lateral incisor was observed in **Figure 3**. This fracture was repaired temporarily with a cold cure. **Figure 4**. The patient did not return for a new prosthesis until another area of the prosthesis fractured after 6 months **Figure 5**.

Figure 5: Repeated fracture of prosthesis

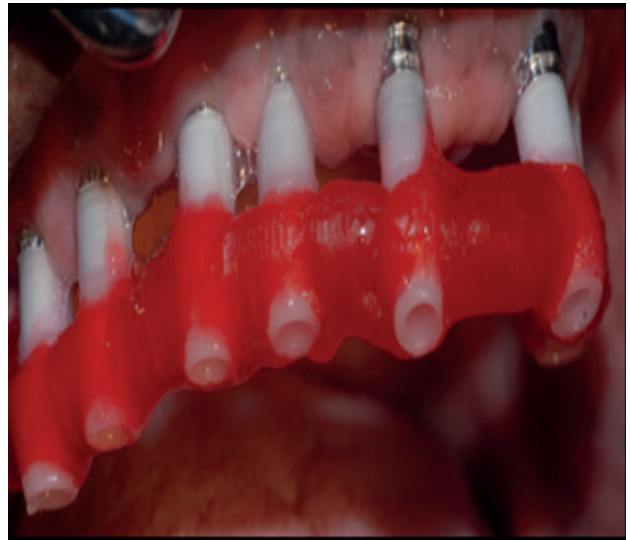
Figure:8 Jig try in with UCLA abutments

prosthesis was sent to the lab **Figure 7**. The present prosthesis helped in confirming the jaw relation, esthetic, and lip support. A jig try-in was conducted with castable UCLA abutments **Figure 8**. The passive fit was ensured by taking periapical radiographs. A framework was made in Cobalt chromium and was tried in the mouth for passive fitting which was ensured with a radiograph. This cast metal framework had metal struts that resemble individually prepared teeth, popularly known as Malo bridge, on which individual crowns could be later fixed. **Figures 9 & 10**. The framework has channels through which the implant screws could be accessed and torqued. This would help in unscrewing the framework for oral hygiene maintenance by the dentist. The crowns were luted with temporary cement individually so that they could be easily retrieved, repaired, and refixed if a ceramic fracture occurs. **Figure 11**. The gingival region of the prosthesis was made with Adoro Gingiva Ivoclar Vivadent. The patient was very satisfied and happy with the final restoration **Figure 12**. Follow-up after one year showed the prosthesis was intact with no fractures **Figure 13**.

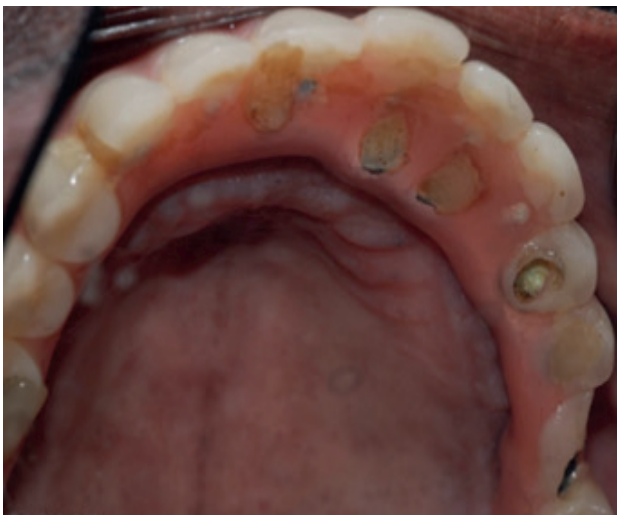
On clinical evaluation, the molar teeth had fractured off, the entire upper denture teeth were abraded, and the composite sealing of the screw access holes had been dislodged with the prosthesis looking stained and unpleasant. **Figure 6**. Treatment planning was done, and it was decided with the patient's consent to proceed with a Malo Bridge. Malo bridge was decided as already the implants were placed and the only option left was to have a strong prosthesis that can be easily repaired without the removal of the entire prosthesis.

Figure 6: Abraded and stained prosthesis

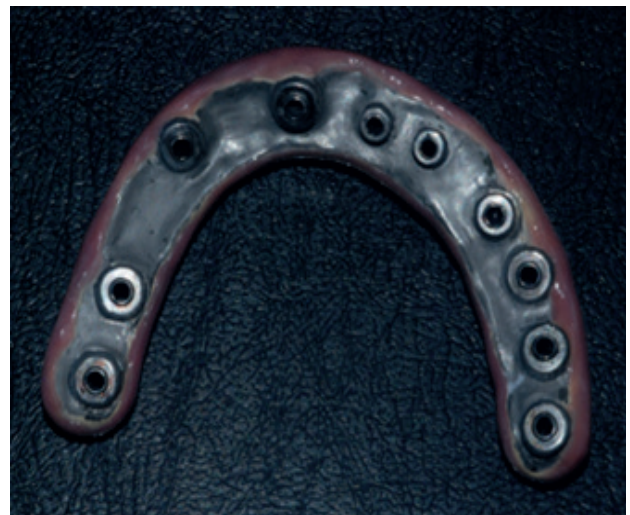
Figure 9: Tissue surface view of the framework

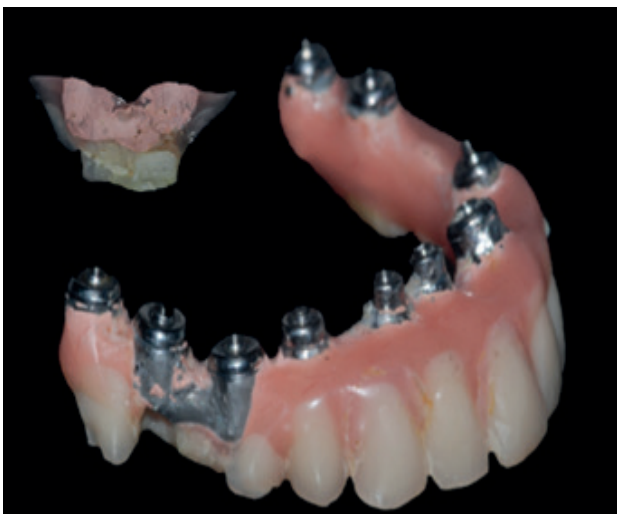
Figure7: Removed hybrid prosthesis.

An impression was made with an open stock tray. The existing hybrid prosthesis was used to make a jaw relation record using bite registration paste. After the jaw registration, the existing hybrid prosthesis was removed by clearing the remaining acrylic over the screw holes and untorquing the screws. The removed

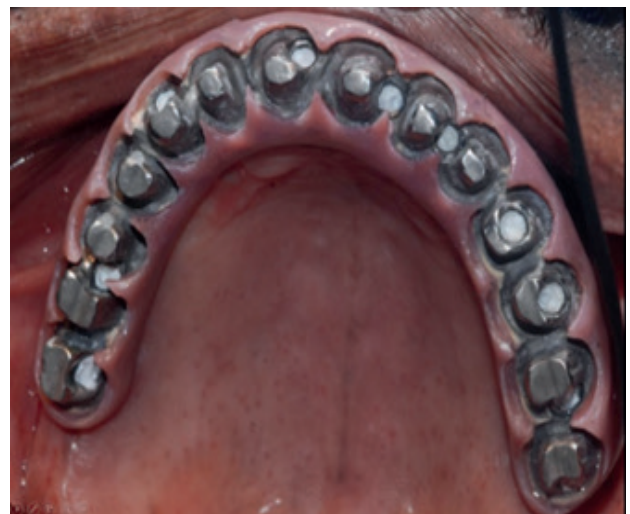
Figure 10: Occlusal view of the framework

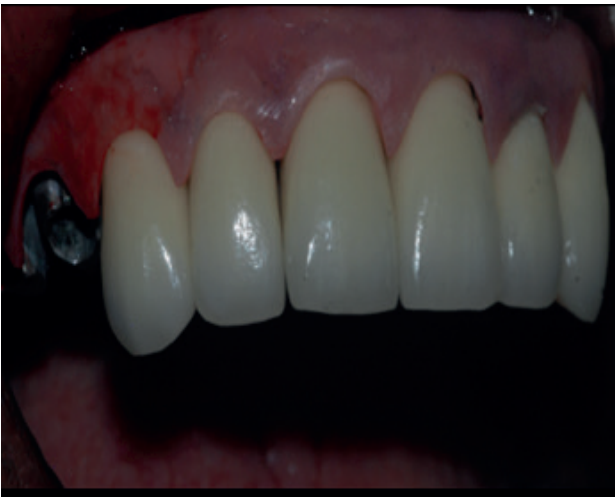
Figure 11: Individual crown cementation

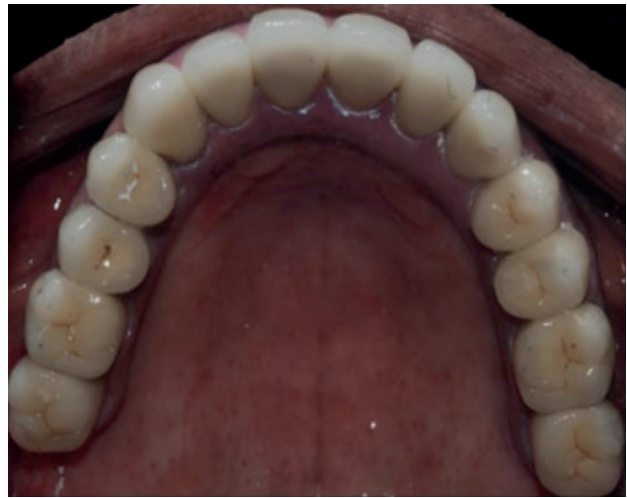
Figure 12: Completed Maxillary Malo bridge.

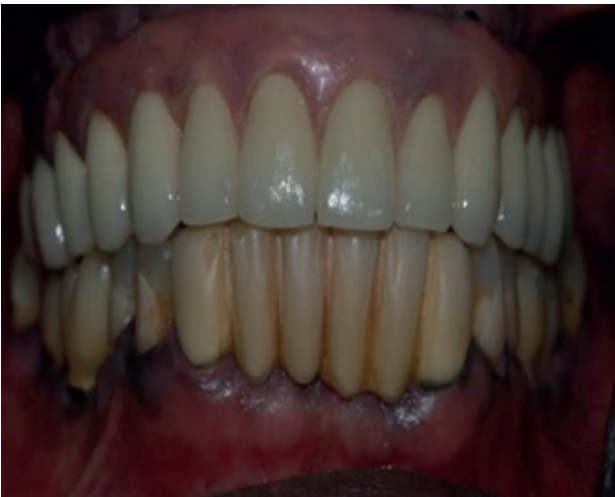
Figure 13: After a one-year follow-up of Malo bridge in Occlusion
