Surgical Exposure of Impacted Upper Right central Incisor and Its Proper Alignment in the Dental Arch

ABSTRACT

Reported case is of a 9-year-old-girl with unerupted malposed upper right central incisor, which was treated by sequential surgical exposure and fixed orthodontic treatment. The tooth was aligned in the dental arch with accepted aesthetic and functional satisfaction of the patient.

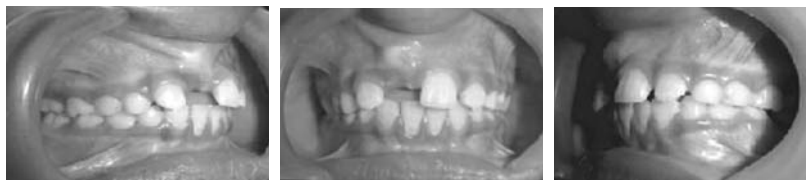
Pre-Treatment Photographs

straight profile with competent lip and good facial symmetry. An angle class-1 malocclusion with impacted upper right central incisor was noted (Fig 1, 2, 3). Clinical assessment of mandibular closure from rest position to habitual occlusion showed no mandibular displacement. No signs or symptoms of TMJ pathology were noted. Panoramic radiography revealed the presence of all permanent teeth with impacted (labio-version) upper right central incisor with deciduous canine and molar teeth (Fig 7).

Fig 1: Rt. Lateral View

Fig 2: Front view

Fig 3: Lt. Lateral View

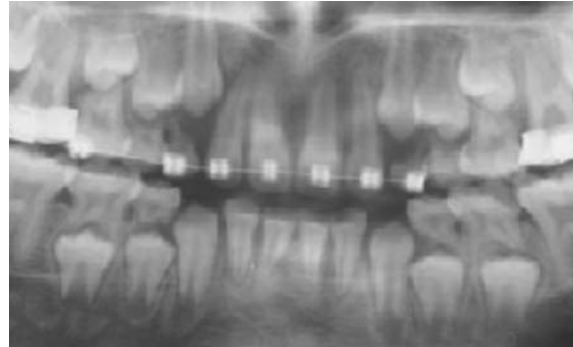
Fig 8: Post-treatment Panoramic Radiograph

One year after the initial treatment, the patient was consulted again with pre-treatment and post-treatment records. A class-I incisor relation was achieved with optimal over-bite and over-jet relationship (Fig 9, 10, 11). The post treatment panoramic radiography revealed a complete eruption of upper right central incisor. The roots of the tooth were fairly parallel, supporting tissues appeared healthy clinically and radiologically (Fig 10, 8).
