Application of GPR to Detect Lost Valve Chambers in a Utility Network

ABSTRACT: The exact geographic location of the fresh water transmission network of Dhaka WASA was not known to the agency. With time and development works, access to many underground valve chambers within the network were lost. Their recovery was usually done through manual digging and trenching. This was expensive, time- and labour-consuming, often led to traffic jams, and the rate of success was low. This study was conducted to use the non-intrusive method of Ground Penetrating Radar to locate those valves as an alternative. A total of 27 out of the 41 lost nodes in the network was successfully recovered and their precise location was recorded using RTK-GNSS. The article presents the detail procedure of locating the valve chambers of underground pipeline network. It also highlights how the lack of collaboration between agencies are causing water supply and maintenance problems to this day, and how infrastructure development of one agency may erode successes of another.

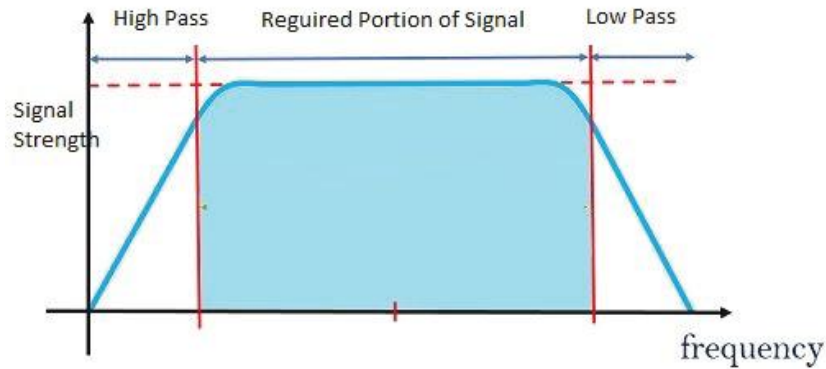
Figure 2: A Band Pass Filter Only Allows the Most Sought after Portion of the GPR Signals to Remain and Removes the Unwanted Lower and Higher Values

The two-way travel time is recorded in the time domain along with the strength of the reflected signal. In the preprocessing stage the raw GPR data containing various types of interference and noise can be improved by band pass filtering (Fig. 2) and gain correction (Benedetto et al., 2017). Also, time-zero correction has been utilized to ease visualization. When the GPR system sends radio pulses into the ground, it takes some time for the system to start recording data. This delay is called "time-zero" and it can cause a shift in the recorded travel time, which can be adjusted to compensate for the changes in the gap between the antenna and the ground surface (Peters et al., 1994). This change in gap was, in turn, forced due to potholes in the surveyed roads. Furthermore, Direct

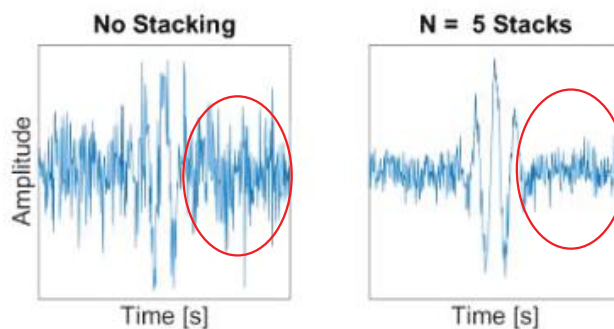
Figure 4: The Signal in Red Circle from the Left Image is Blurry but the Stacked Graph in the Right Shows How Noise is Reduced Through Stacking. (GeoSci Developers, 2017)

Current (DC) correction (Fig. 3) was used to remove the constant or slowly varying signal components from the GPR signal, since it usually masks the weaker signals (Fisher et al., 1992). All traces are then stacked (Fig. 4), where subsequent GPR traces are averaged

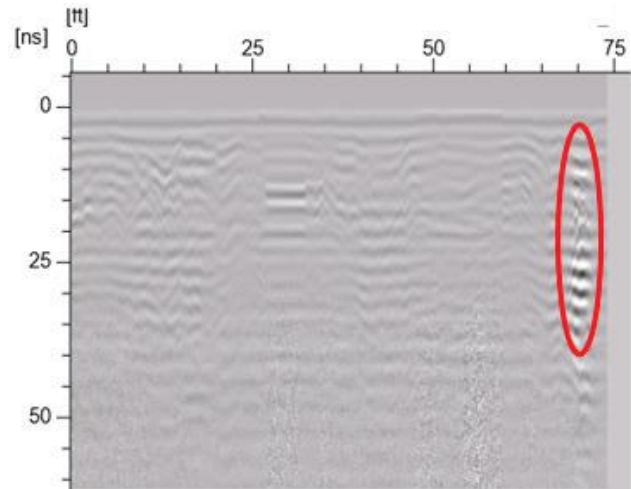
Even though ringing responses are usually strong but it does depend upon chamber depth. The East Rampura

survey showed a faint signal (Fig. 10). Since there were no other signal of that strength in the vicinity we assumed that this might be our target object. Drilling confirmed our suspicion.

Figure 10: Only a Faint Ringing Response was Found in East Rampura, Indicating that Much Attenuation had Occurred

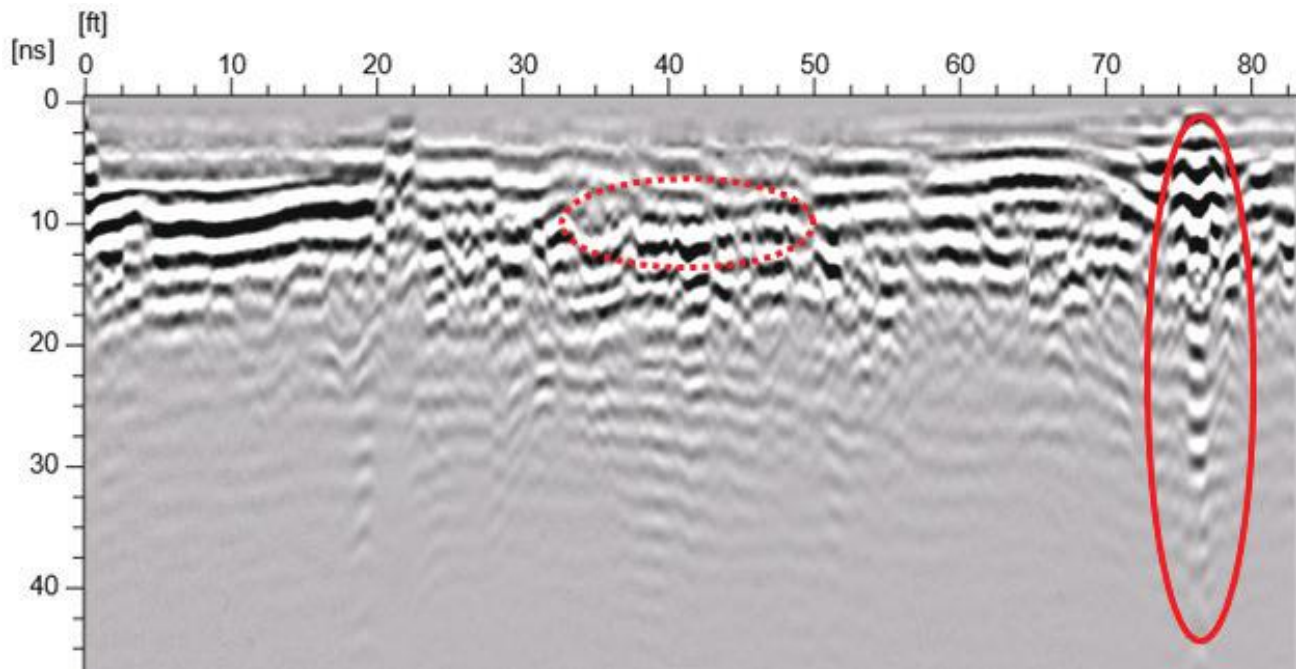
Figure 11: The Chamber Near Hatirpul Mor also Showed Ringing Response from its Manhole Cover

Most of 27 successful cases were found from the ringing responses. However, the problem arises when the roads are underlain by a wide variety of utility lines, as is the case with Dhaka. The Hatirpul Mor radargram (Fig. 11) shows a rebar pattern (indicated with a red dashed

line). Initially we assumed that this corresponds to our target. Drilling revealed that it was in fact a chamber but belonged to another network. Oftentimes we found that the fresh water transmission pipes run parallel to the sewerage and storm drain network.

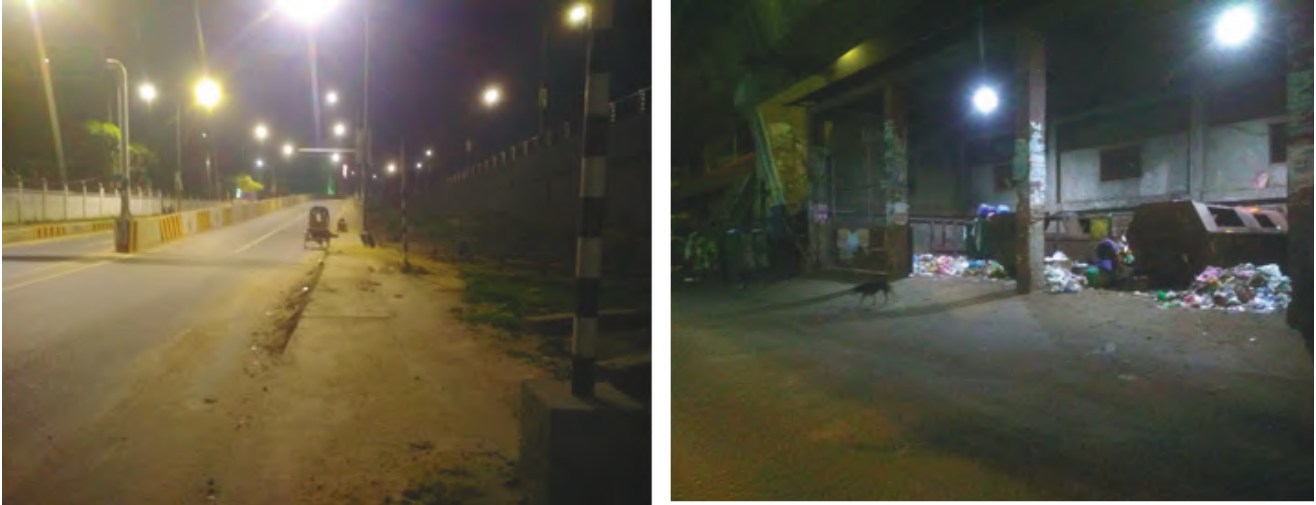
Figure 16: (Right) In Postogola, a Bridge Ramp was Constructed Over the WASA Network Node. (Left) In Jatra-bari a Garbage Storage Station was Constructed Supposedly Over the Chamber. The Road Sections were Surveyed and no Significant Signatures were Noticed. Our Conclusion is Derived from Eye Witness Accounts of Locals and WASA Personnel

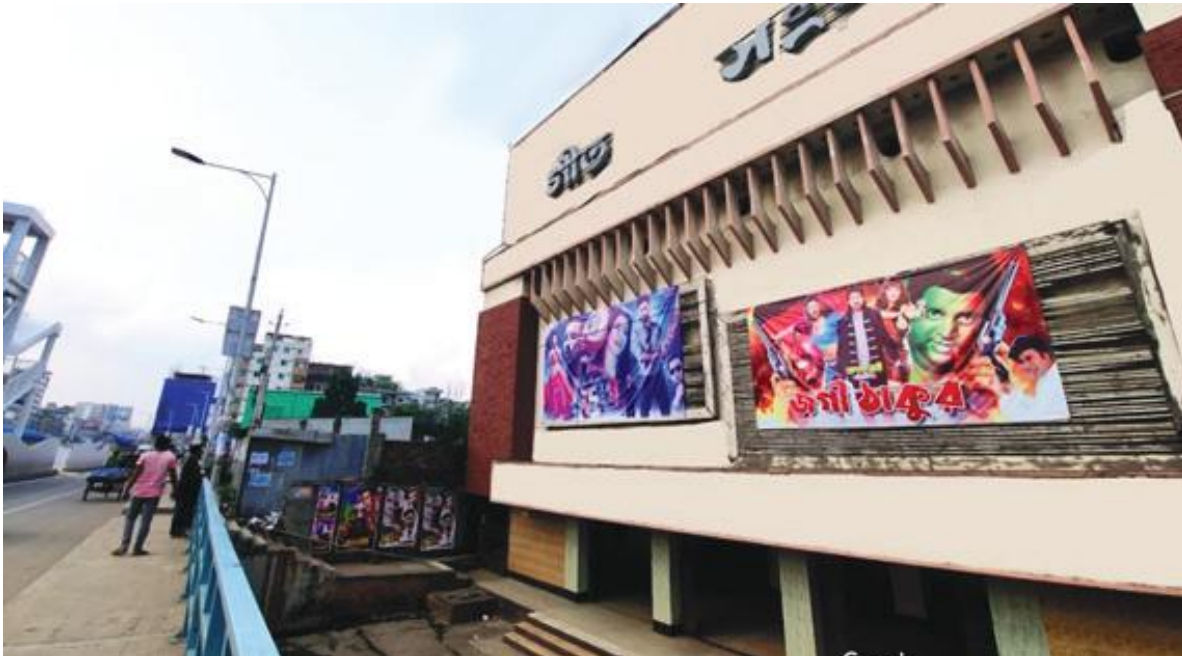
WASA's freshwater network lines also exists near the Dhaka-Mawa highway. Due to development work this road was raised several feet. The chamber was located near the Geet Sangeet Cinema Hall (Fig. 18). Since the

road was raised several feet we believe the chamber was at well below 15 feet from the current ground surface. We were unable to locate this chamber simply because of the limitation of our GPR instrument. In similar

Figure 18: This Picture is Intended to Show How Much the Road was Raised. The Current Road Surface is the One Where the Person in Pink T-shirt is Standing Upon. The Road Surface Used to be at the Same Level as the Entry Way (to the Lower Right Hand Side) of the Geet Sangeet Cinema Hall. A Stairway (Center) now Connects the Hall to the Current Road. (Picture by Akash Ariyan is Collected from Google Maps)

works such as in Spain by Ayala-Cabrera et al., (2011) and in Gujarat, India by Joo and Agrawal, (2021) range-

adjustable frequency antenna is used that allows better penetration.
