ELEMENTAL ANALYSIS OF OLD MORTAR USED IN VARIOUS ARCHAEOLOGICAL SITES OF BANGLADESH BY SEM AND EDAX

Abstract

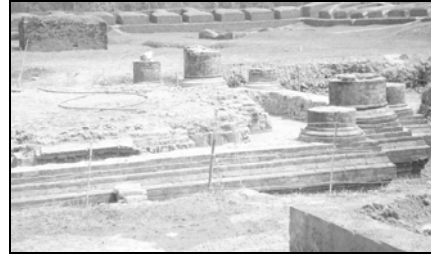
Photo 2. Small cruciform temple at Salban Vihara.

Lalmai-Mainamati (6th to 13th centuries A.D.): Lalmai-Mainamati was one of the attractive places for the Buddhist community. Rashid (1997) reported that it was the second largest city of ancient Bangladesh in which the religious establishment, together with large Viharas and the constituent's colleges of the Buddhist University, were built. Hossain (2007), Ahmed (1975) and Rashid (1997) reported that huge collection of artifacts, large number of *stupa* and monastery indicate that the site was flourished from 7th to 13th centuries A.D. Ali and Alam (2000) and Rashid (1997) reported that some structural remains have been discovered by excavation at Lalmai-Mainamati from 1955 to 2000. These are Salban Vihara, Kutila Mura, Charpatra Mura, Rupban Mura, Itakhola Mura, Anada Vihara, Bhoja Vihara, Lati coat Mura, and Queen Mainamati's palace mound. During (2008-2009) excavation, a small cruciform temple (Photo 2) and *stupa* near to Salban Vihara were discovered.

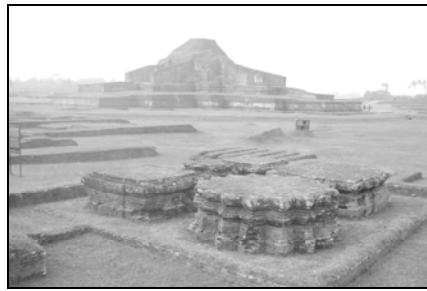
Photo 3. Paharpur main temple at Naogaon.

Paharpur (8th to 13th centuries A.D.): The archaeological remains of Paharpur (World Cultural Heritage Site) represent the most spectacular and magnificent monument of Bangladesh. It is the second largest Buddhist monastery situated at the South of the Himalayas. It is also known as Somapura Mahavihara (Photo 3). Excavation at Paharpur was carried out by G.C. Chandra during 1925-26, 1930-32 and Dikshit in 1928-29 and 1934 under the supervision of Archaeological Survey of India (ASI). A report on Paharpur archaeological excavation was published by Dikshit in 1938. Alam (2004) reported that, with the help of UNESCO, the Department of Archaeology skillfully excavated the site in 1981-82, 1984-85, 1988-89 and 1990-91 and three major building phases in the monastic cells were established. Rectangular monastery with 177 cells and *Varanda*, a cruciform temple, different types of *stupa*, viz. star shape, octagonal, square, and votive *stupas* are the main features of Paharpur archaeological site.

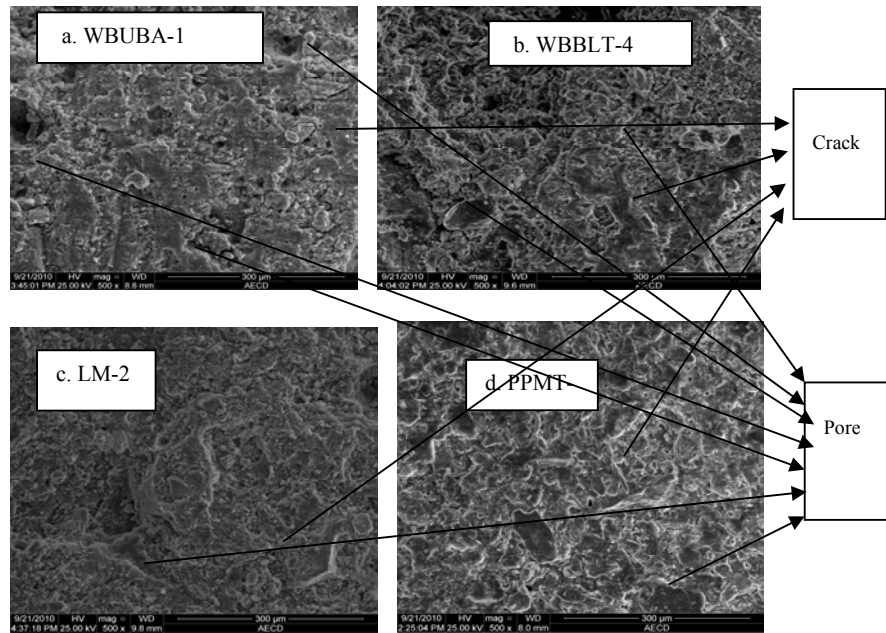
Morphological study of Mortar: In the present study, it was observed that surface of the mortar was rough. A large number of cracks were found in the samples of WBBLT 1 & 4. Big size pores were found (20 μm) in the samples of WBBLT-4 which indicate weakening of the joint areas. Small sizes of pores and cracks were found (1 μm) in the

sample of LM-2, and PPMT-1, which indicates strengthening of the joint areas of these sites (Fig. 1 (a, b)). A few number of pores were found in the samples of LM-2 and PPMT-1 which indicates that the joint area is stable of these sites (Fig.1 c, d). It is understandable that the cracks and pores are responsible for the deterioration of mortar strength in different locations of these sites. Pore is one of the physical criteria which enhancing deterioration of mortars as well as brick masonry walls.

Fig.1. SEM images showing cracks and pores of mortar samples: a. WBUBA-1, b. WBBLT-4, c. LM-2 and d. PPMT-1.

Deteriorating agents like wind, dust and dirt, rainwater, ground water, flood water, atmospheric gases, acidic ion, salt, and plant-roots can easily enter into the mortars through the pores and cracks. Large number of pores and cracks are helpful for intruding rainwater, air and ions inside the mortars, which played significant role for the deterioration of mortars. These were observed in the West wall of Buddhist Lotus Temple in Wari-Bateshwar. Small sizes pores were found in the samples of newly discovered “Small Cruciform Temple” near the Salban Vihara at Lalmai-Mainamati. Hence, stability of mortar was found well in Lalmai-Mainamati sites leading to less damage of the architectural remains of these sites.

Cracks and pores are responsible for the deterioration of mortar strength in the joint areas of Buddhist Lotus Temple at Wari-Bateshwar. Stability of mortar was found well in Lalmai-Mainamati and Paharpur main temple leading to less damage of the architectural remains of these sites. The absence of Ca in the mortar samples indicate that clay mortar was used for the architecture at Wari-Bateshwar, Lalmai-Mainamati, and Paharpur. The ancient architecture of Wari-Bateshwar, Lalmai-Mainamati, and Paharpur were constructed with bricks where clay was used as mortars. Na and Fe can retain of moisture and water easily that can deteriorate of mortars faster. Oxidation of Fe^{+2} produced Fe_2O_3 which was responsible for breaking down the bonding of mortars.

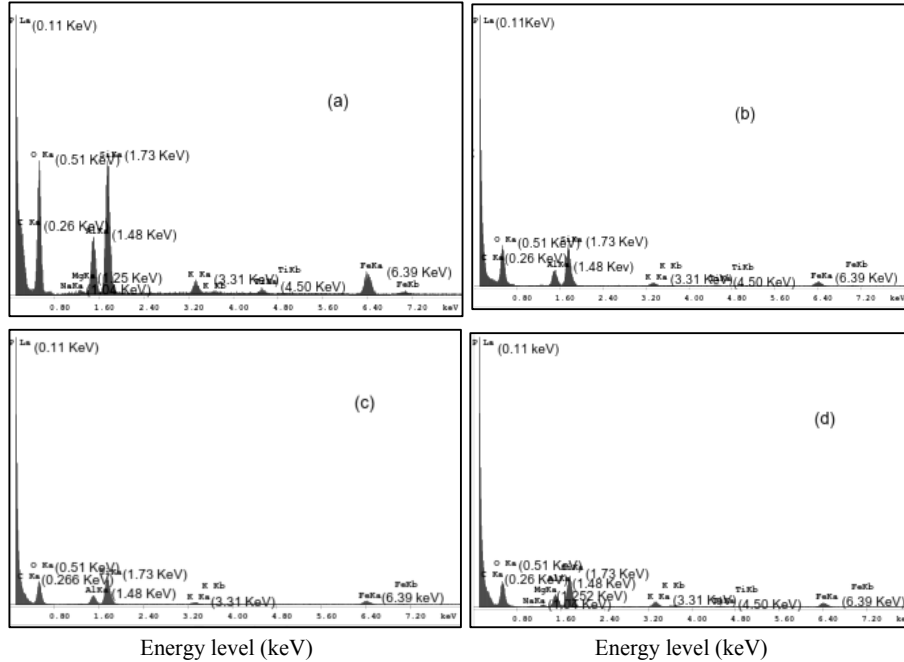
Elemental analysis of mortar: Representative examples of elemental spectrum of mortar samples, where the following elements have been found: C, O, P, K, Al, Fe, Na, Mg, Mn,

Si, and Ti are presented in Fig. 2(a-d). Each element has its individual energy for its K_{α} and K_{β} shells. In Fig. 2 individual elements are shown with their corresponding K_{α} and K_{β} energy level. Energy level of each element is shown in the parenthesis. K, Ti and Fe show two peaks, K_{α} and K_{β} . The Multi Channel Analyzer (MCA) was calibrated using known standards and then the corresponding energy level was detected for each element. For each element corresponding counts were used to calculate the concentration by comparing the counts of standard of same element. Counts of all the overlapping peaks (K_{α} and K_{β}) were separated by using K_{β} / K_{α} ratio.

Fig. 2. EDAX spectrum showing various elements of mortar sample: (a). WBUBA-1, (b). LM-1, (c). LM-2 and (d). PPMT-1.

Elemental concentrations of C, O, P, K, Al, Fe, Na, Mg, Mn, Si, and Ti have been determined and listed in Table 1. The principal constituent was found as Si. Higher rates of O_2 (21.98 to 35.80 wt.%) and Si (13.52 to 25.16 wt.%) have been found in all the mortar samples which might come from SiO_2 . Higher amounts of O_2 (35.80 wt.%) and Fe (20.94 wt.%) have been found in the mortar samples of PPMT-2 which indicate weakening the joint areas at Paharpur main temple. Less amount of Al (5.06 to 11.10 wt.%), K (1.98 to 6.98 wt.%) and Mg 0.44 to 2.12 wt.% have been found in most of the samples. 1.6 wt.% of Mn has been found in the sample of WBBLT-4. Quartz is the most stable of all minerals in the earth surface environment (Rapp *et al.* 1930). Higher amount of Si and O_2 might come from sand. The study indicates that clay with sand has been
