Case Report

Management of a Complicated Crown Fracture in a Tertiary Care Hospital

J Enam Med Col 2017; 7(1): 35–38

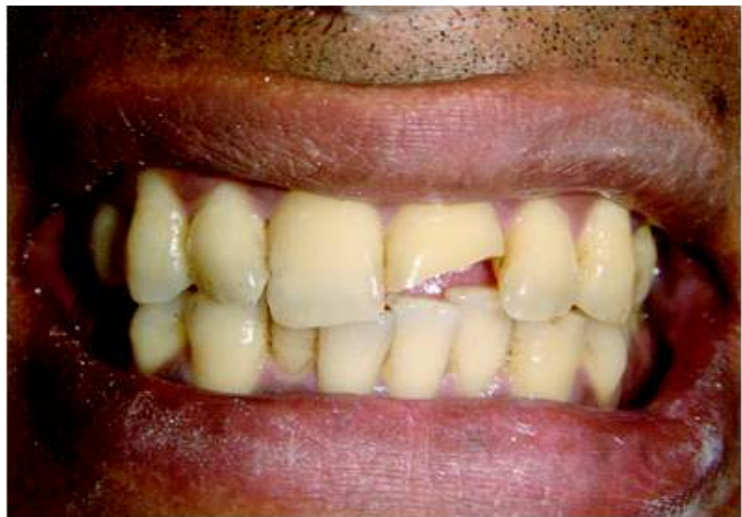
Fig 1. Initial photograph showing oblique coronal fracture

A 35-year-old male patient reported to the dental unit of Enam Medical College Hospital, Savar, Dhaka with the complaint of mild pain and broken tooth on the maxillary anterior region. He had a history of trauma on that area one week back due to an accident. On extra-oral examination no abnormalities were detected, intra-oral examination revealed an oblique coronal fracture of maxillary left central incisor with involvement of pulp (Fig 1). The fracture line extended a little below the gingival level at the palatal surface of the tooth. Intra-

oral periapical radiograph revealed an intact periodontal ligament space with no root or alveolar bone fracture. The case was diagnosed as complicated crown fracture of maxillary left central incisor. After considering the above conditions, endodontic treatment followed by restoration with glass fiber post and direct composite crown build-up was planned.

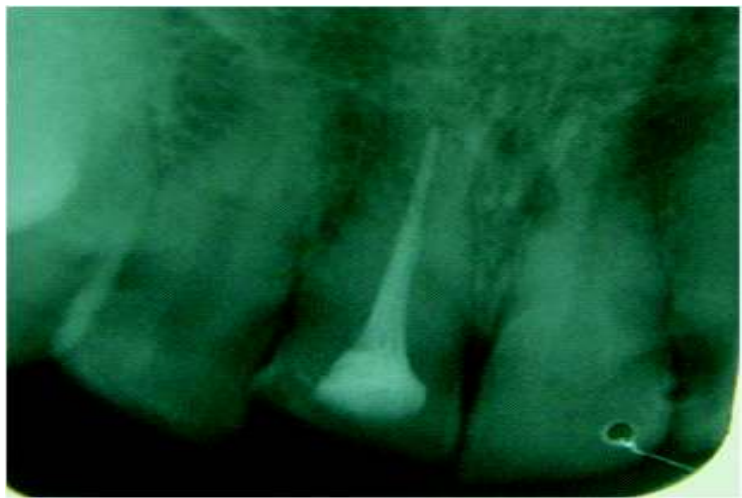
Fig 2. After root canal obturation

With consent of the patient, local anesthesia was administered and gingivectomy was done to expose the line of fracture palatally and hemostasis was achieved. Then a straight line endodontic access cavity was made and pulpal remnants were removed. The working length was determined by working length measuring radiograph. Then the root canal was prepared as standardized technique at 18 mm working length up to 60 K file and obturated with gutta-percha point by lateral condensation technique (Fig 2).

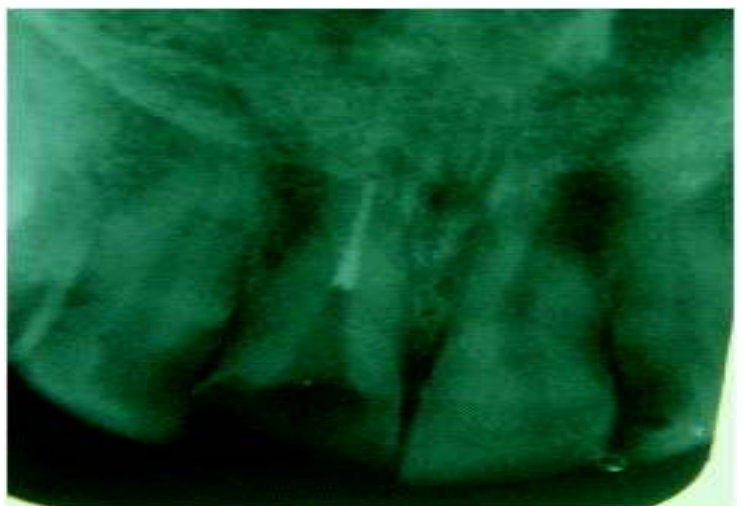
Fig 3. Remaining gutta-percha after partial removing

On the next appointment, the gutta-percha point was partially removed from the root canal using peeso reamer until it measured the estimated depth required for the post, leaving 5 mm of filling material at the apex to maintain a good seal (Fig 3). The glass ionomer luting cement (GC corporation) was applied with a lentulospiral into the post space and the glass fiber post (GLASSIX-1.35 mm diameter) was inserted into the canal (Fig 4). Excess cement was removed with a clean instrument.

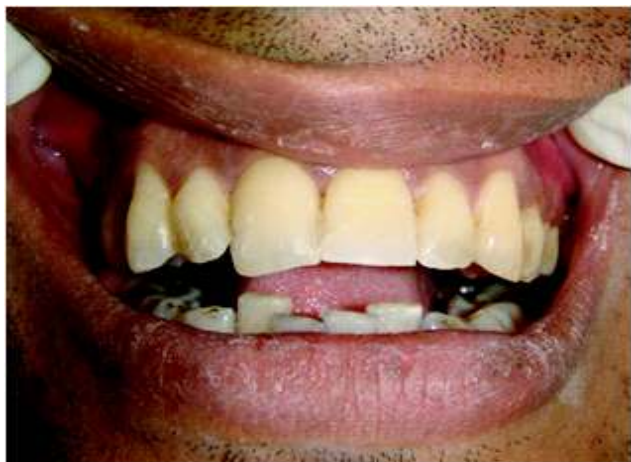
Fig 5. Final photograph after build-up

Then the shade was selected, the tooth was isolated with cotton roll and air dried. Uniform layer of 7th generation self-etch adhesive bonding (beauty bond) was applied according to manufacturer's instruction. The adhesive layer was dried with gentle air blast for five seconds and light curing was done for 10 seconds. Then the crown was built up incrementally with Giomer (beautiful II-# A2). Each increment was light cured for 20 seconds. Then the tooth was finished and polished and occlusion was checked (Fig 5).
