AMELIORATION OF ACID SULPHATE SOILS IN NILWALA RIVER BASIN

N. Senanayake^{1*}, M.T.M.D.R. Perera² and A. Weragoda³

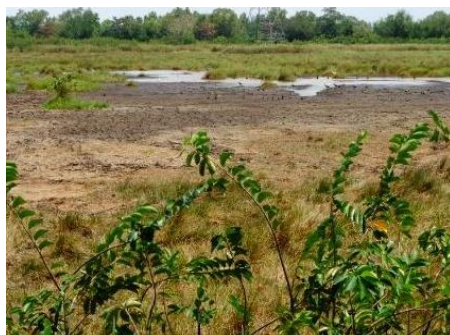
Figure 1. Area affected by extreme acid sulphate conditions

A pilot area of the drainage channel segment of about 250 m length from NFPDP, where a flat land, consisting of about 5 acre of paddy land affected by acid sulphate soil (Fig. 1) was selected in the Kotawila, Godagama area closer to Agriculture Research Station (ARS), Telijjawila with road accessibility. The only vegetation growing in the site is a plant called “TIKIYA” (*Eliocharis dulcis*), the only plant that survives under acid saline soil conditions (Balasuriya, 1987).

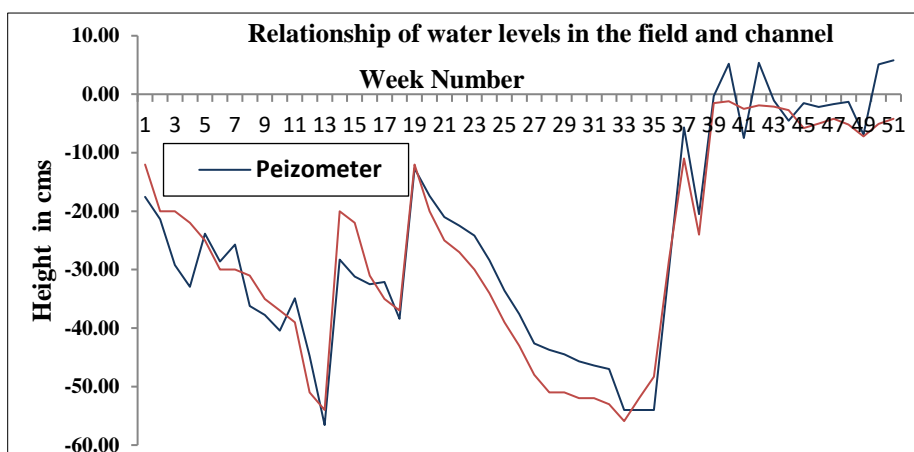
(a)

Water table depth in the field and water level in the channel was monitored for a period of one year at 2-week intervals and the data were summerized to weekly averages and presented in the Fig. 2a. It shows the comparative depths for the week 1-51 and weekly variation in water levels, which follows a similar trend. The lower readings in week 14-19 could be attributed to the heavy rainfall (172 mm in November and 128.6 mm in December) in the catchment area inundating the paddy lands and as the rain water from higher elevations in the channel moves down towards the site increasing the water level in the channel and decreasing the water table depth in the paddy fields. These levels in the drainage channel are measured from a reference point marked on a permanent water controlling structure (which is in par with the soil surface of the paddy land) at the highest elevation in channel section of the site.

Figure 2. Relationship of water table and water level with changes of pH (b) and EC (c)

Correlation analysis of the water table data (Fig. 2a) showed that there is a very high correlation ($r^2=0.985$), which proved our second hypothesis, where natural hydraulic forces operating in the site and therefore heading up of water in the channel can elevate the water table in the paddy fields, keeping the jarosite oxidation at bay. Further, the changes in pH values between water table depth in the paddy fields and water level in the drainage channel (Fig. 2b) also showed a good correlation ($r^2=0.90$) throughout experiment period. This also proves that oxidation reduction processes also operational in the site and if we can head up water in the channel then the soil reduction takes place and pH values decrease to acceptable levels for paddy cultivation. Similarly, EC values (Fig. 2c) also showed a good correlation ($r^2= 0.975$) and could be brought to levels acceptable for paddy cultivation.

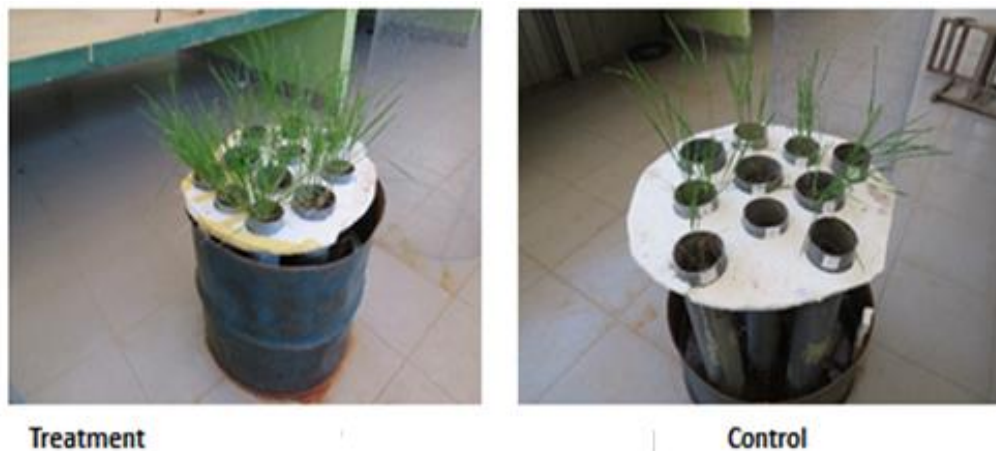
Figure 3. Plant growth after 14 weeks for different treatments

A simulated pot experiment inside the greenhouse was conducted (Fig. 3) to find out the feasibility to raise a rice crop with increased water table. In this pot experiment Maha 20/21 rainfall of project site was simulated by adding measured quantities of water. However, Maha 2020/21 appears to be exceptionally dry (Table 2) and all of the months except January 2021 the rainfall received was less than 10-year average.

As a result, the plants did not grow to a height of more than 35-40 cm, due to physiological water stress experienced by the rice plants because of low amount of rainfall received and long spells of dry weather and high intra plant competition. Normally Bg 357 rice plant grows to a height of 56 cm (RRDI, Personal communication). Moreover, growth period of the rice plants was also extended by about 7-10 days.

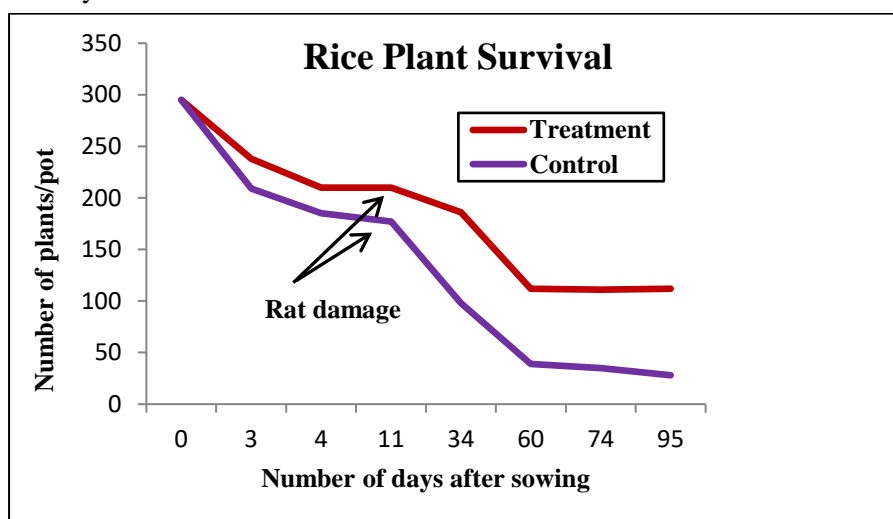
Figure 4. Rice plant survival for different treatments over time

Plant Population count was also taken at weekly intervals and data represented in Fig. 4. After 9 days after planting seeds of the rice plants were eaten by rats and population was reduced to 210 and 185 plants for treatment and control respectively and the plant count was reduced to 112 and 28 plants respectively at the end of experiment period. Therefore, the survival of plants was 53% and 15% for the treatment and control respectively.

High plant mortality was observed in the control treatment (28 plants) due to development of acid sulphate conditions by oxidation of jarosite and high survival of rice plants in the treatment (112 plants) where water table is within the root zone of rice plants and jarosites are under reduced conditions. Changes in soil pH and EC was
