# Operation and Maintenance of Secondary Reformer – Lessons from Plant experiences

Sk Shafi Ahmed<sup>a\*</sup> and Md. Enamul Haque<sup>b</sup>

<sup>a</sup>Chief Operations Officer, Karnaphuli Fertilizer Company limited; Rangadia, Anowara, Chittagong

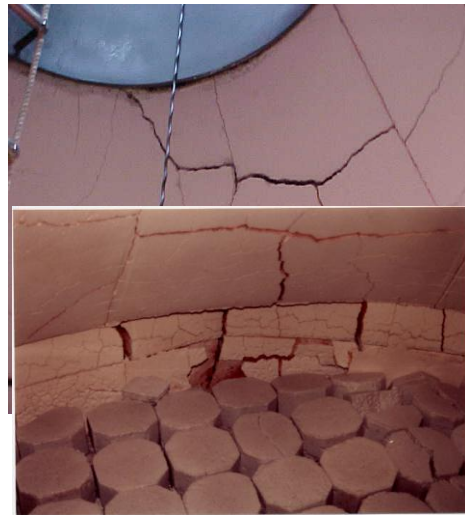
Figure 4: Castables inside 2RF

Condition of Castables – Sound from rubber hammer  
Cracks; progress of cracks and propagation

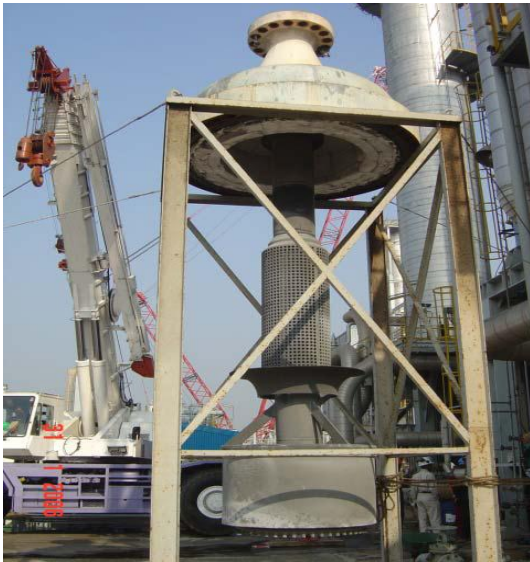
Figure 7: H<sub>2</sub> Burner within the 2RF

- Check for cracks especially in welds
- Burner tips – deformation or crack.
- Top ring of the refractory box – Deformation
- Refractory wool –Condition and missing.
- Refractory work- required and the quantity
- Plate replacement and Material.
- Refractory in the dome shows no severe damage

The DPT of all welds of the Burner.

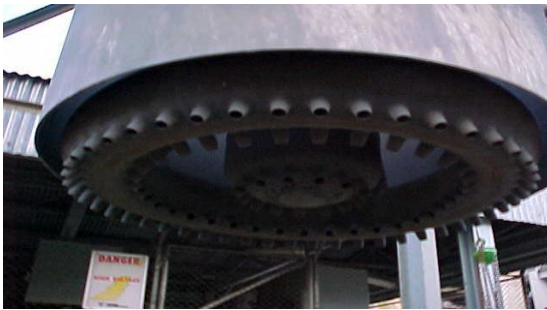
Figure 8: Tip of the Burners

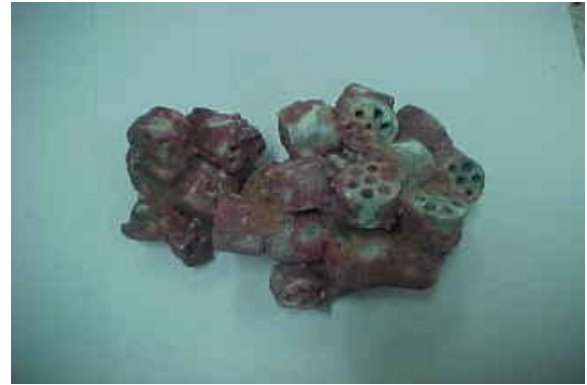
Figure 10: Catalyst with lump

Catalyst under the bricks – Colour especially ruby formation Catalyst dust –Presence and amount

Ruby formation of catalyst -- characteristics and location – e.g center and peripheral areas

Under the top layer catalyst bed - lots of catalyst dust was and ruby formed catalyst presence.

Catalyst is carefully monitored during all or alternate Turnarounds (TA). All broken catalyst; dust and agglomerated catalyst is removed during this period. The whole bed in unloaded to do the job. The catalyst unloading help inspection of the bottom arch.

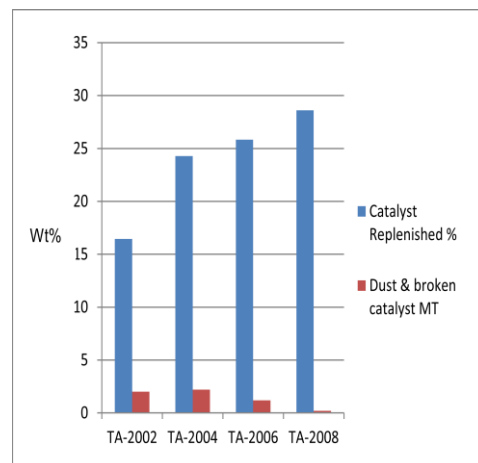
Table-1: Dust and Broken Catalyst Removal

Turn Around	Catalyst Replenished wt%	Dust & broken catalyst, MT
TA-0202	16.44	2
TA-2004	24.29	2.2
TA-2006	25.84	1.2
TA-2008	28.61	0.2

Figure 13 : Comparing Dust and Total catalyst
