## Case Report

# Management of Fractured Endodontically Treated Tooth by Fibre Optic Composite Post-Core-Crown: A Case Report

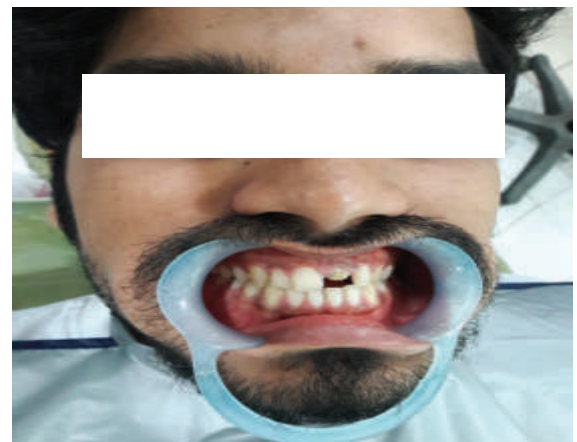
On extra-oral examination, no abnormality was detected. Intraoral examination revealed a cervical crown fracture of endodontically treated maxillary left central incisor.

Figure 1: Fractured left maxillary central incisor

After proper counseling, the consent of the patient was taken. Faulty prosthesis was removed by Tungsten Carbide bar and mouth preparation was done by scaling (Fig 1). Correction of faulty endodontic treated tooth was done by re-RCT. The length of the sealed canal was approximately 20 mm. Preparation of sealed canal for fibre-post was done by removal of gutta percha using peso-reamer leaving 4 mm at the apical region (Fig 2). A radiograph was taken for post direction evaluation into the canal. An anti-rotational groove was applied into the labial wall of the canal. Then application of gingival retractor was done. Then the post space was dried with air and cotton pellet. The glass ionomer luting cement was applied with a lentulospiral #40 into the post space and glass fibre post was inserted into the canal (Fig 3). The post was stabilized for approximately 6 minutes for proper setting.

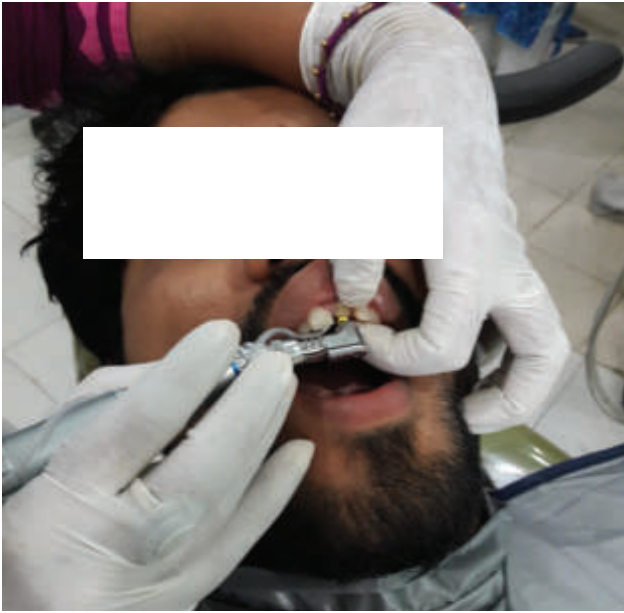
**Figure 2: Canal preparation for fibre optic post**

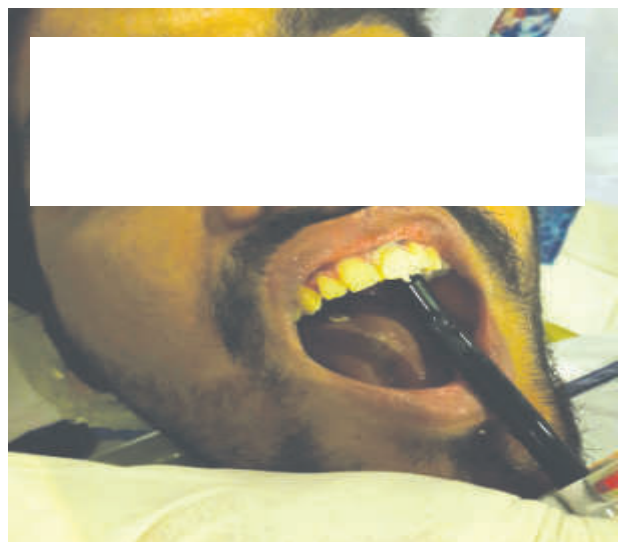
**Figure 4: Composite core**

After proper stabilization of the post, the tooth was isolated with cotton roll and was air dried. Uniform layer of 7th generation self-etching adhesive bonding was applied according to manufacturer's instruction. Light curing was done for 10 seconds. Then the coronal portion was built up incrementally with composite resin. Each increment was light cured for 20 seconds. Then the core was left alone for 10 minutes to allow polymerization shrinkage (Fig 4).

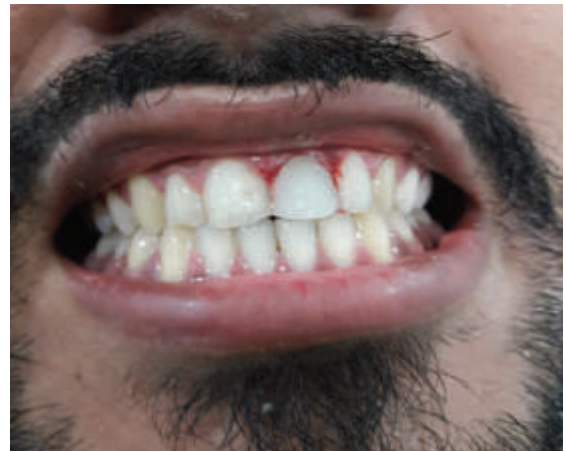
**Figure 5: After tooth preparation**

After core built up, the tooth was prepared with a 1.5 mm ferrule in order to ensure long term post and core performance beneath the crown restoration without sharp line angles for the planned metal ceramic restoration (Fig 5). The color of the final restoration was selected with a shade guide. After tooth preparation, impression was taken with C-silicon impression material and cast was fabricated, sent to the dental laboratory for fabrication of metal ceramic crown. Insertion of the temporary crown was done for preservation of finish line and prevention of inclination of the adjacent teeth (Fig 6). Metal try-in, then porcelain try-in was done. Masticatory function, optimal aesthetics and maxilla-mandibular relationship were obtained. Finally, the metal-ceramic crown was cemented by glass ionomer cement (Fig 7). The patient was advised, not tearing hard food with this restored tooth. After one month, the patient was recalled for follow up visit. The patient had no complaint about the metal-ceramic crown.

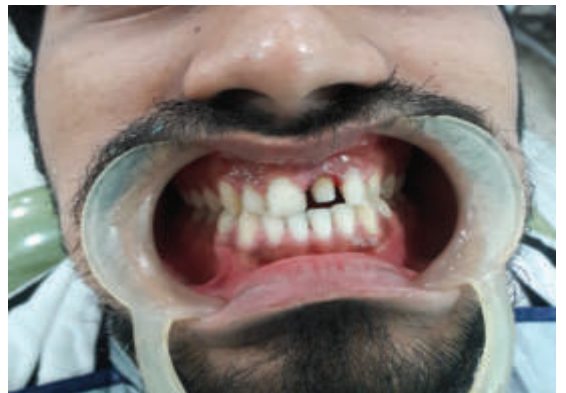
**Figure 6: Insertion of temporary crown**

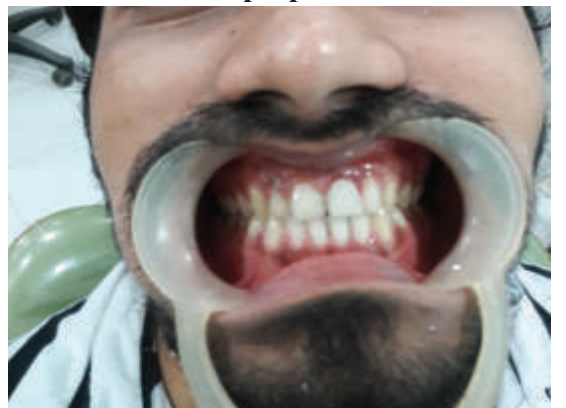
**Figure 7: Insertion of full veneer crown**

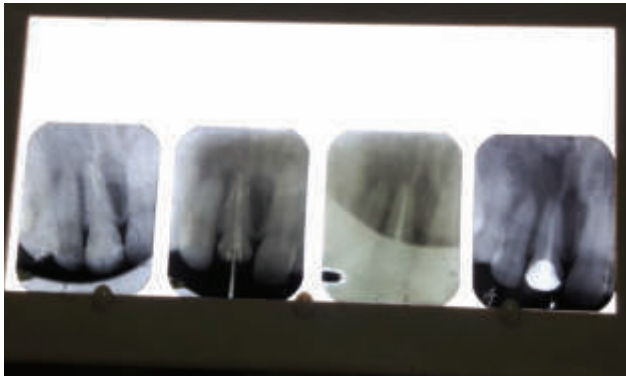
Intra-oral periapical radiograph revealed the under-sealed endodontically treated maxillary left central incisor and no radiolucent area around the root apex of the offending tooth with no root or alveolar bone fracture.

**Figure 8: Periapical X-rays (before & after treatment)**

Figure 8 shows x-ray views of the tooth before and after treatment. The treatment procedure adopted solved the complaints of the patient and the patient was happy after finishing of treatment.
